LEVEL 3

# Your survey report...

Inspection date  
16/08/2024

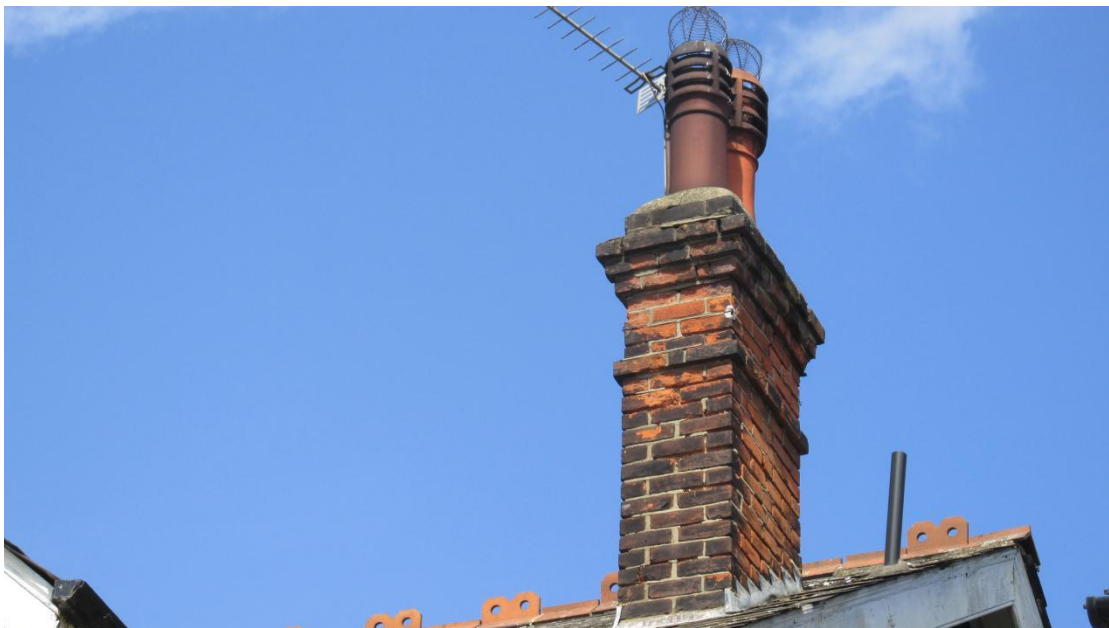
Right Chimney Stack from the front

The condition of the chimney appears to be satisfactory because most of the pointing is intact. Some of the bricks on the right chimney stack show signs of frosting. They might need replacing soon. The lead dressing at the base of the stack is to prevent water ingress. It is in below-average condition. It does seem to be watertight.

The missing pointing on the chimney stack must be repaired. The condition of the flaunching should also be investigated and repaired. Ensure the lead flashing in the base performs well and is watertight.

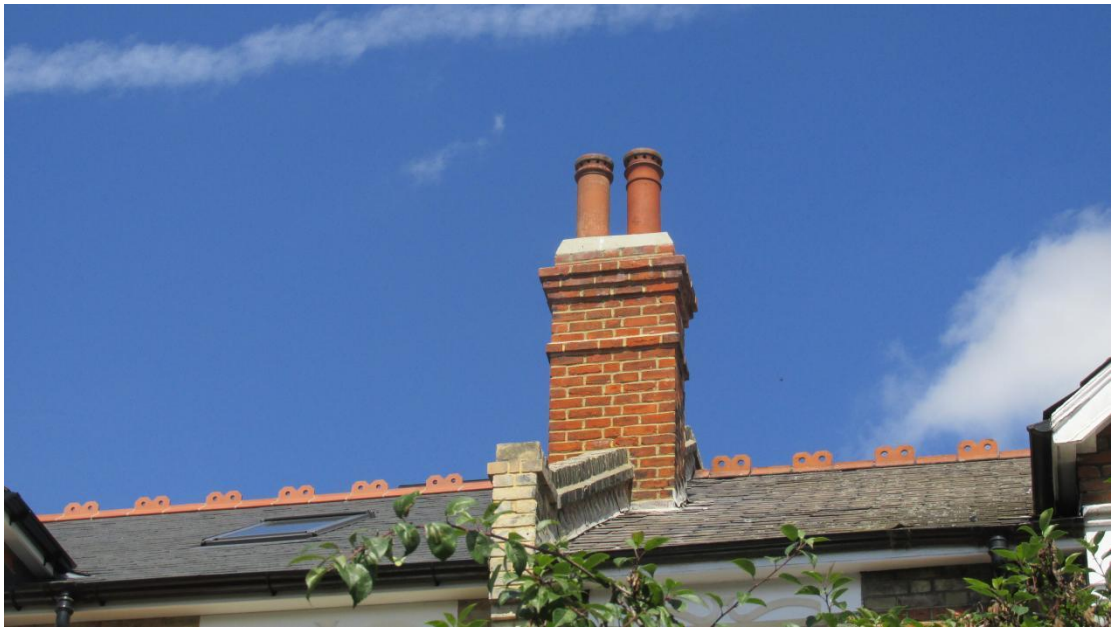
Left chimney stack from the front

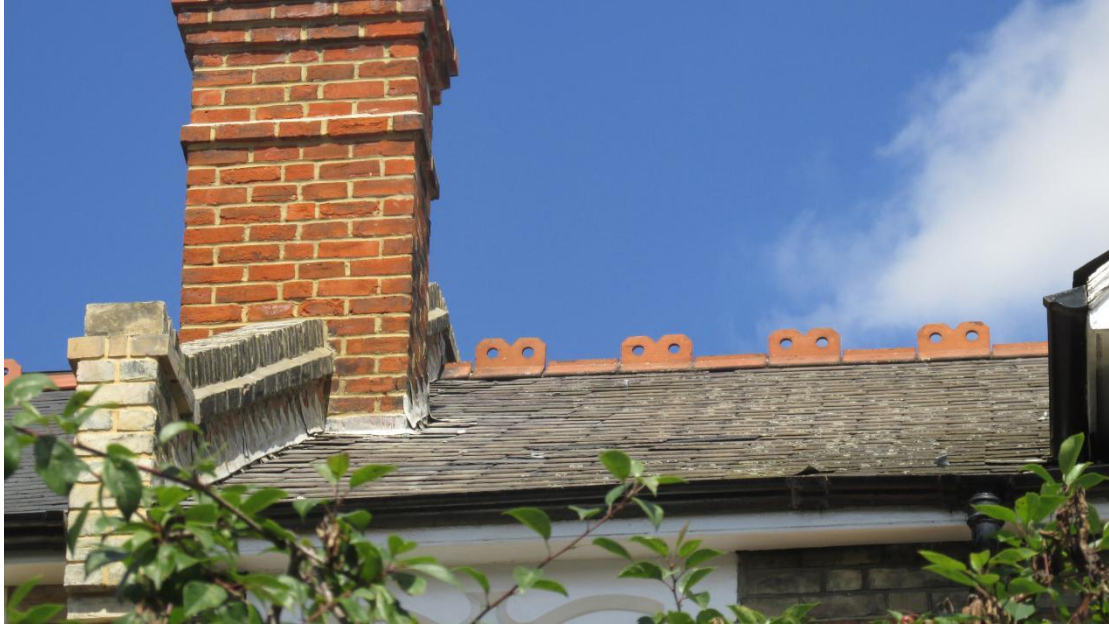
Roof covering from the front left

The main roof is a dual-pitch roof in below-average condition. The roof covering is at least fifty years old. It does not have a considerable serviceable life ahead. The average life of the D-slate roof is sixty years. There are no slipped tiles on the main roof. The ridge is straight, and no sagging is observed on this roof.

The main roof is in average serviceable condition. Lichen and must be cleared from the roof.

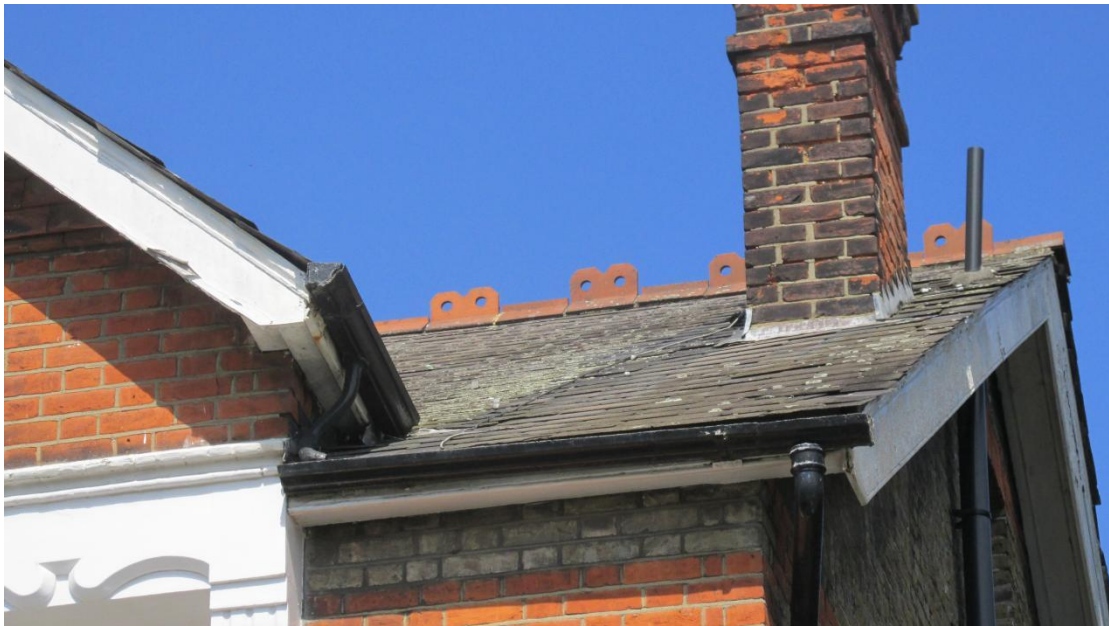
Roof covering from the front right

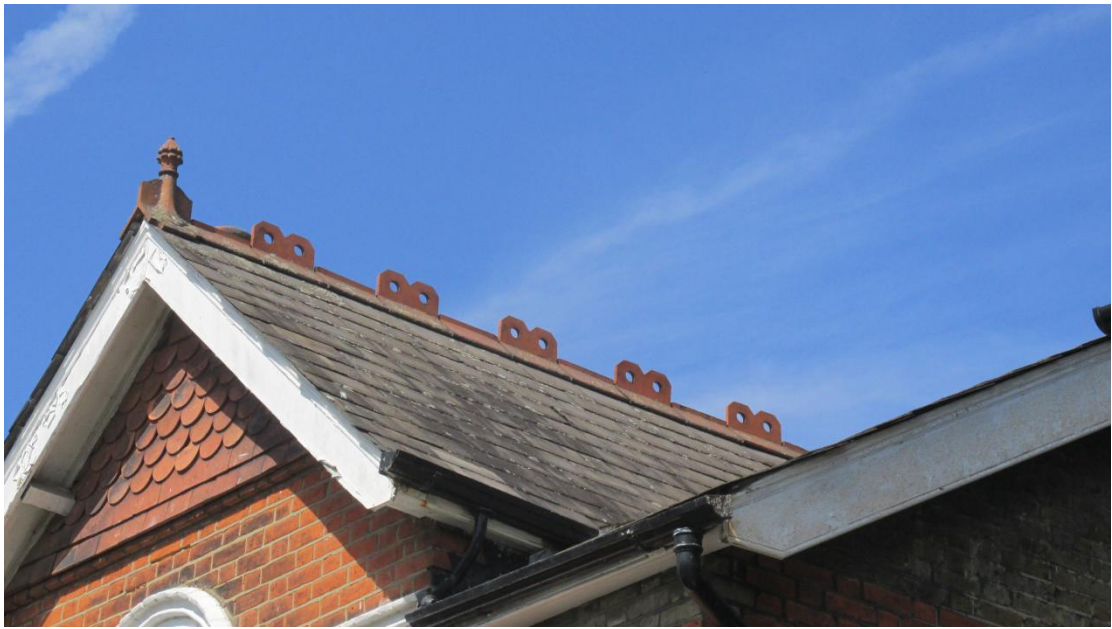
Front gable roof from the right

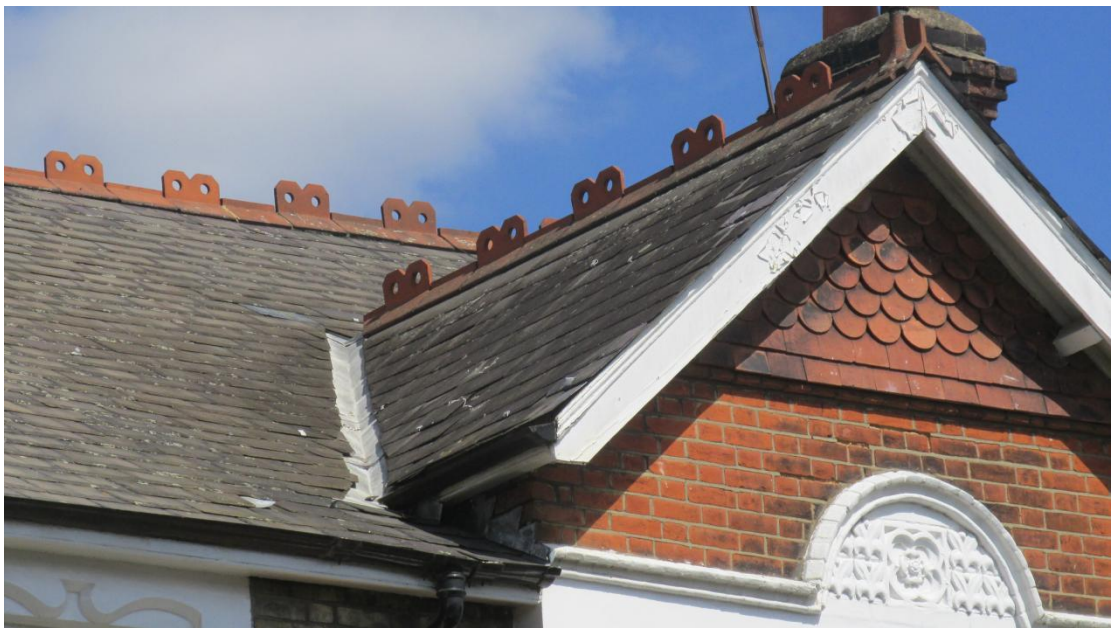
Roof on the front gable from left

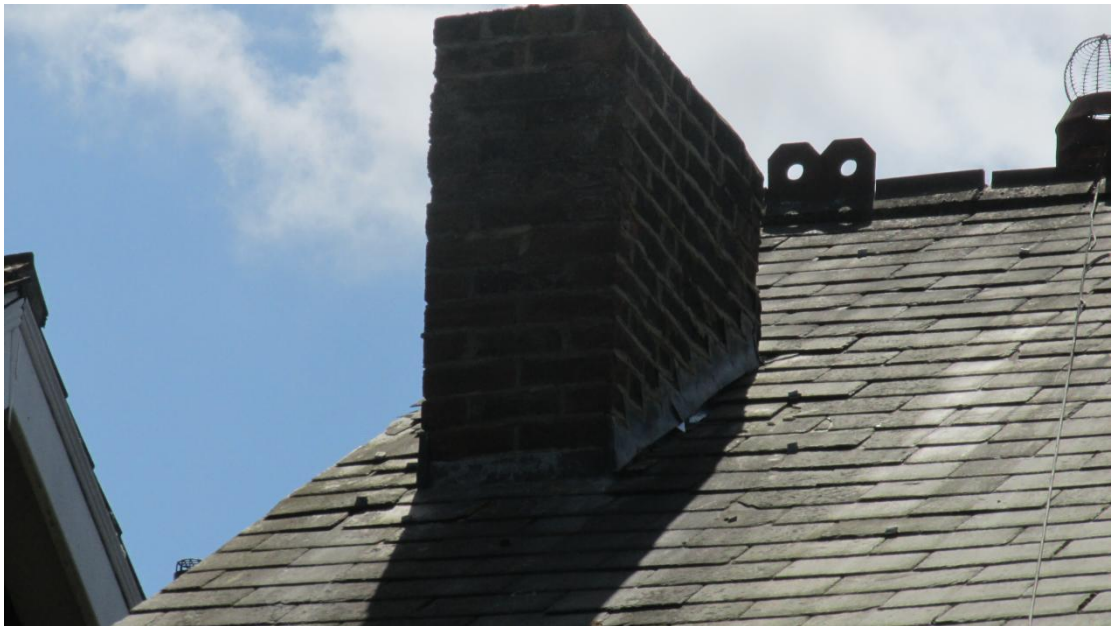
Roof from the rear

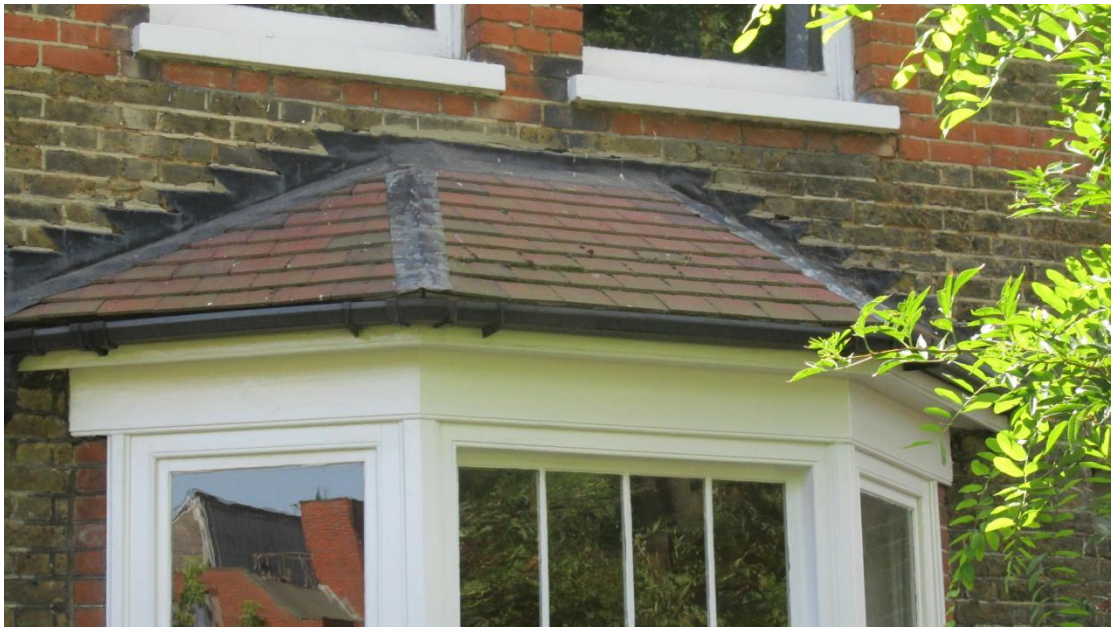
Roof on the rear bay window

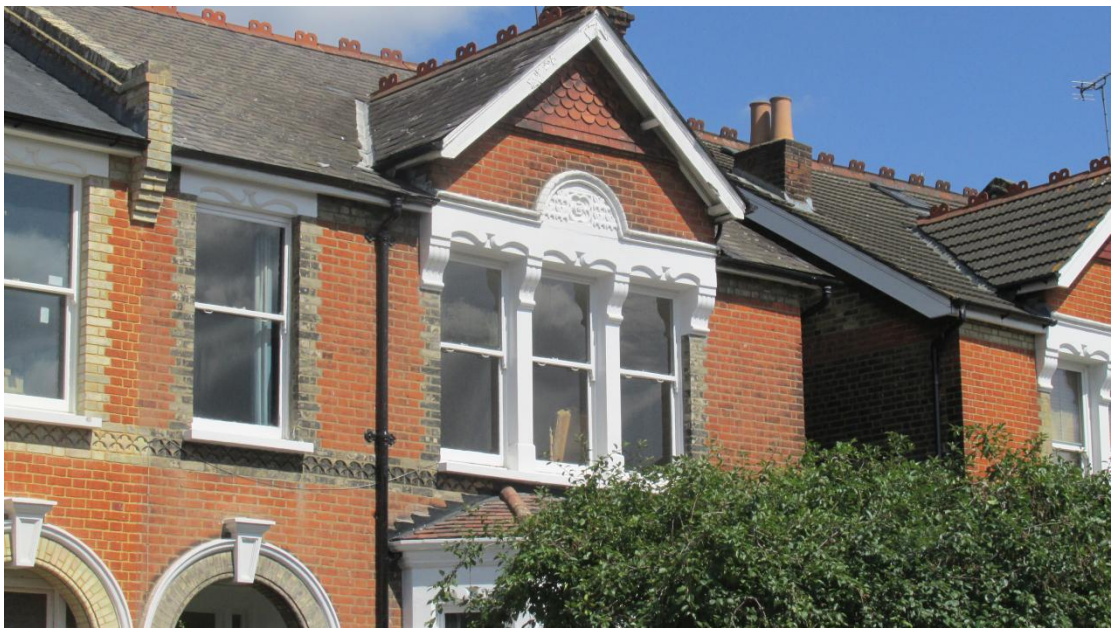
Roof on the front bay window

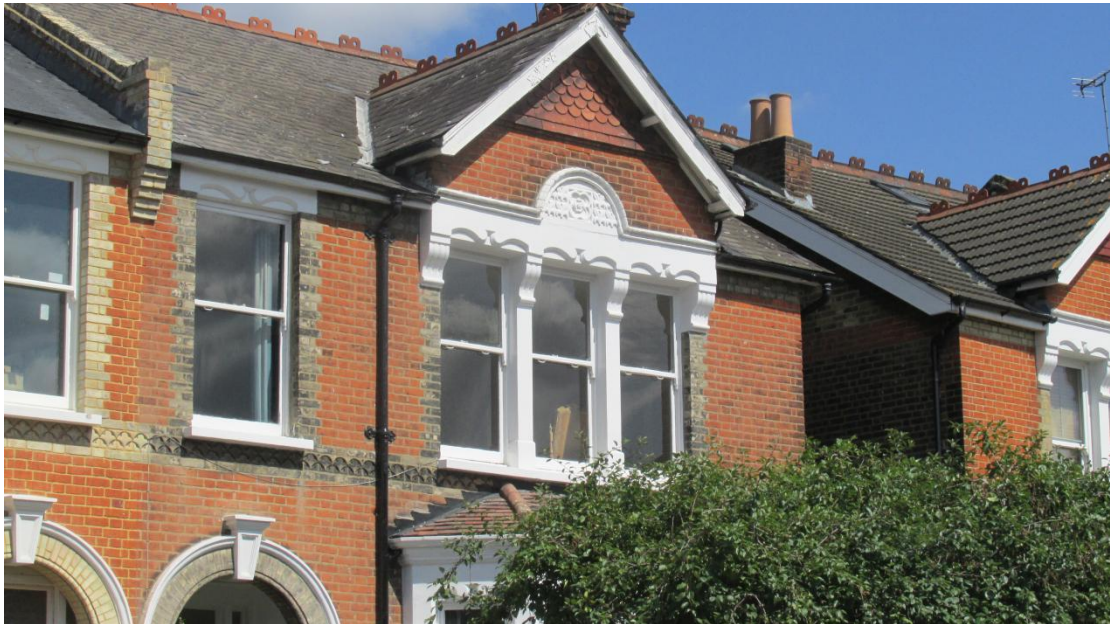
Gutters and downpipe at the front

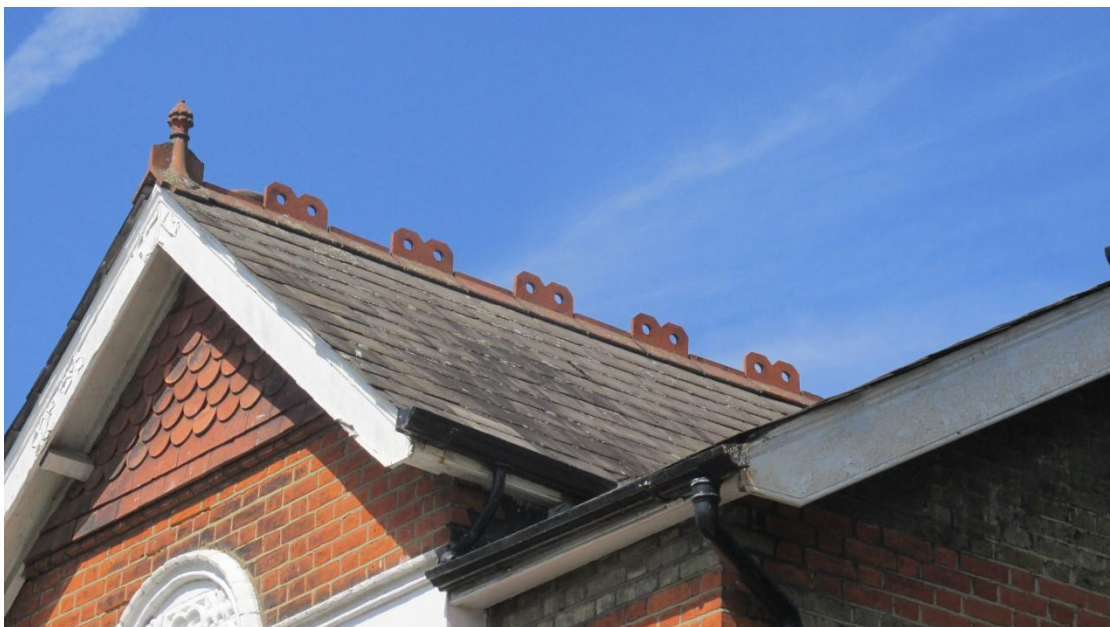
Gutters and down pipe at the right front

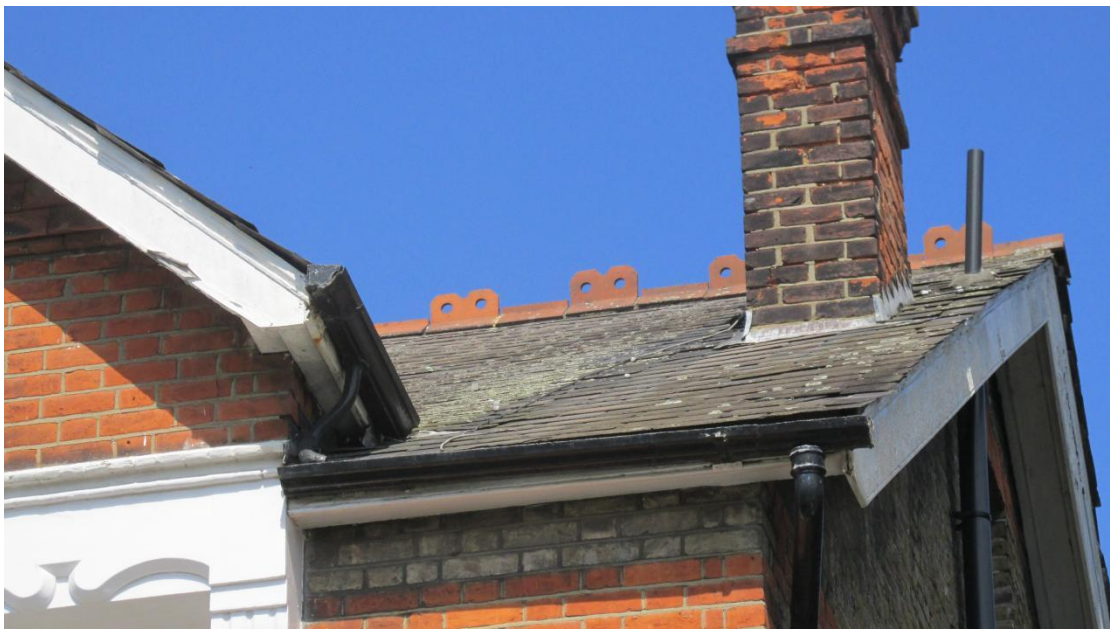
Soil vent pipe through the roof but bird protection cage is missing

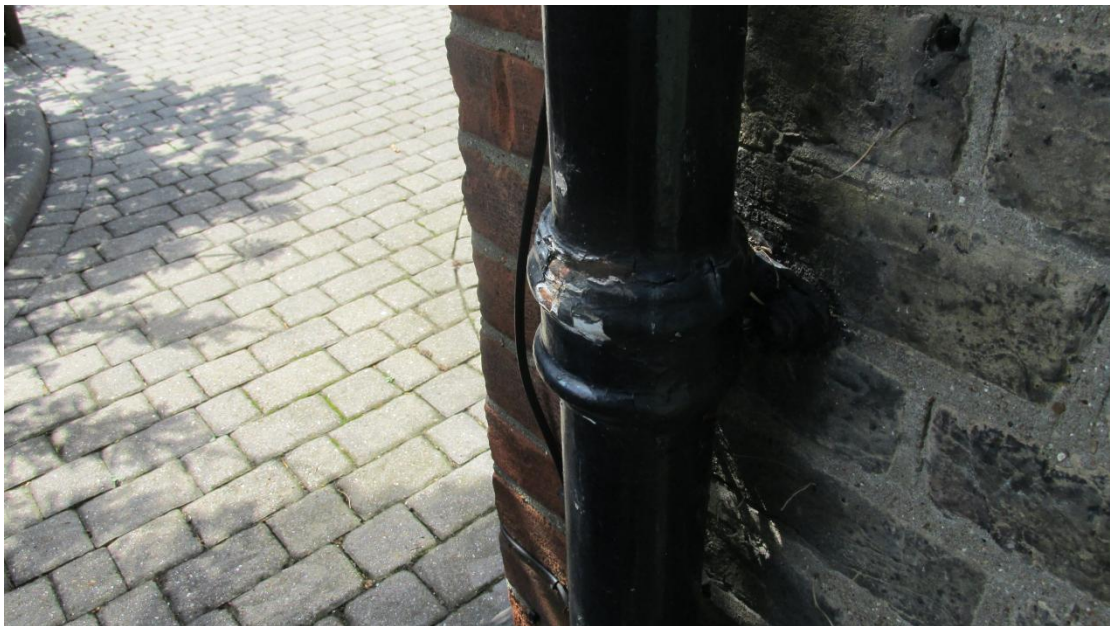
Damaged downpipe at the front

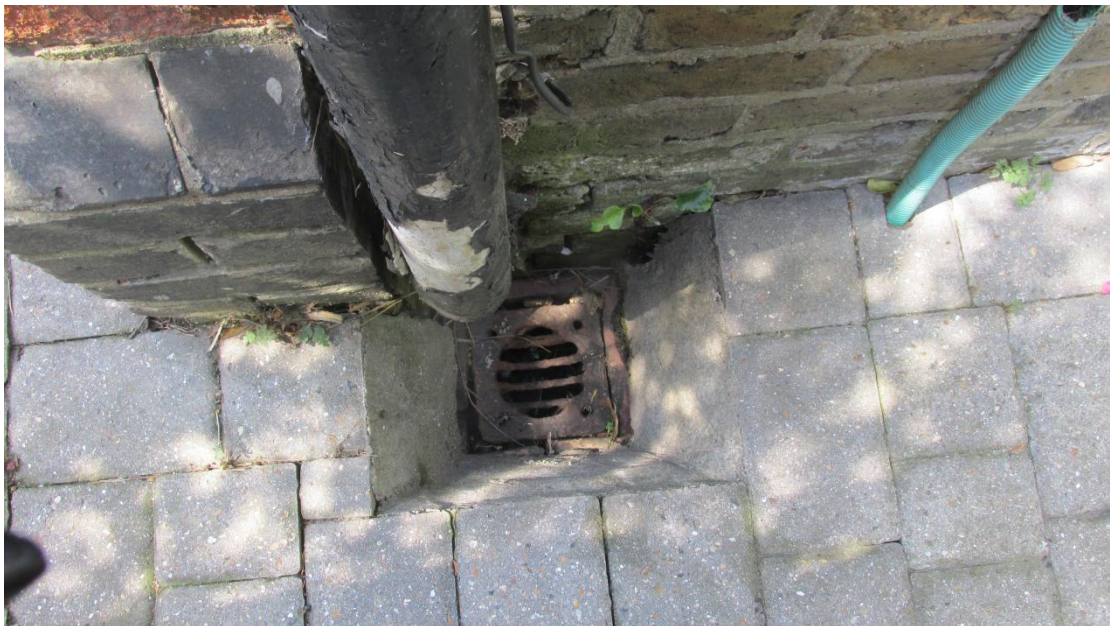
Downpipe gully

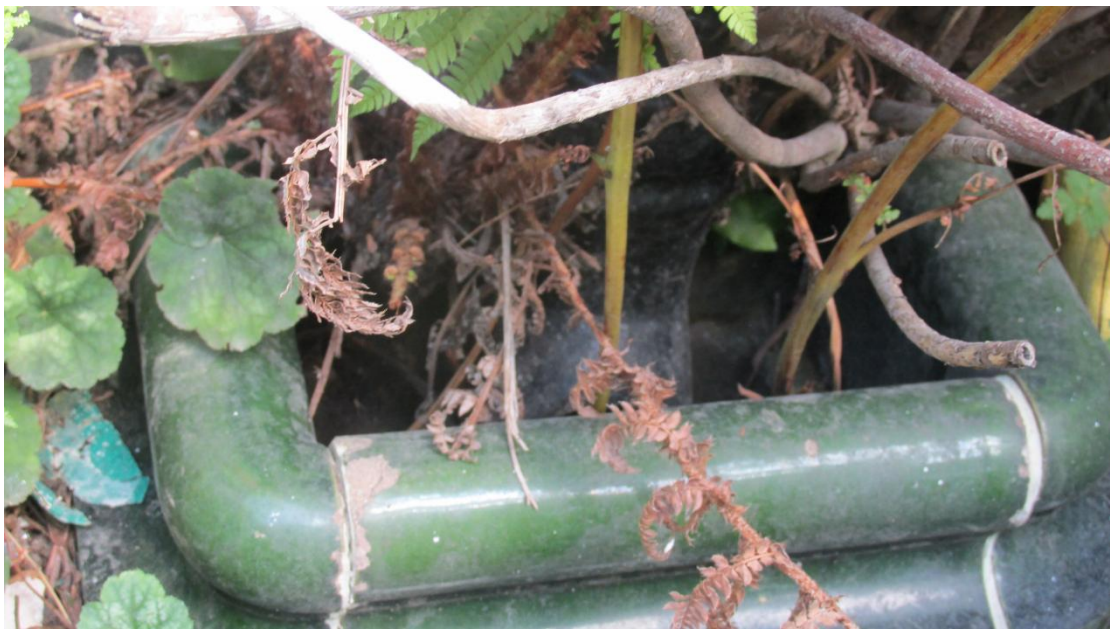
Downpipe gully at the front full of vegetation

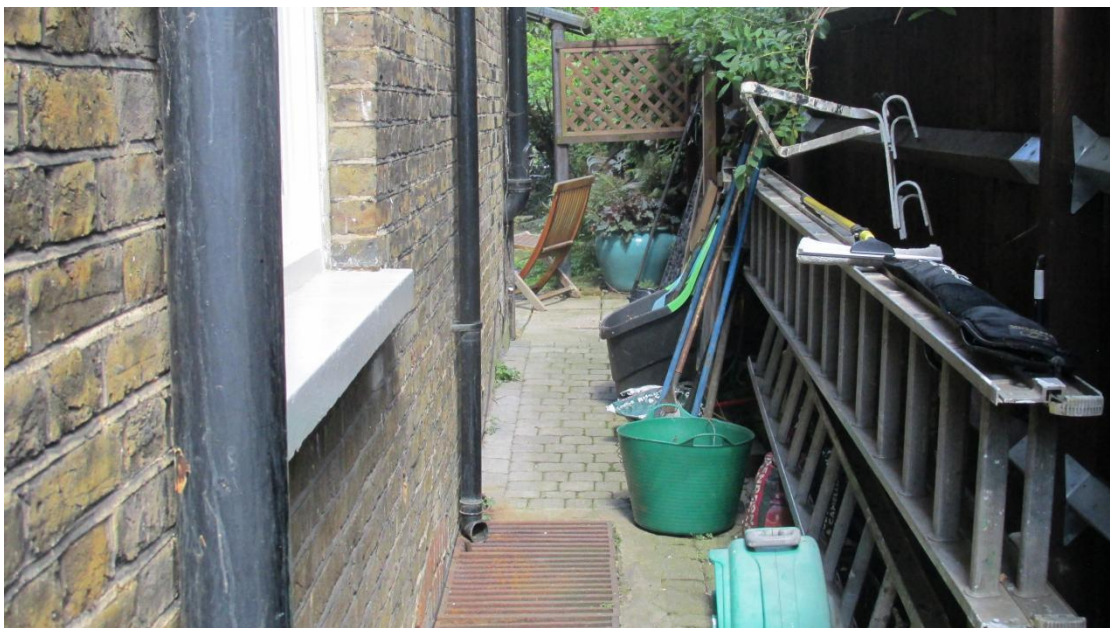
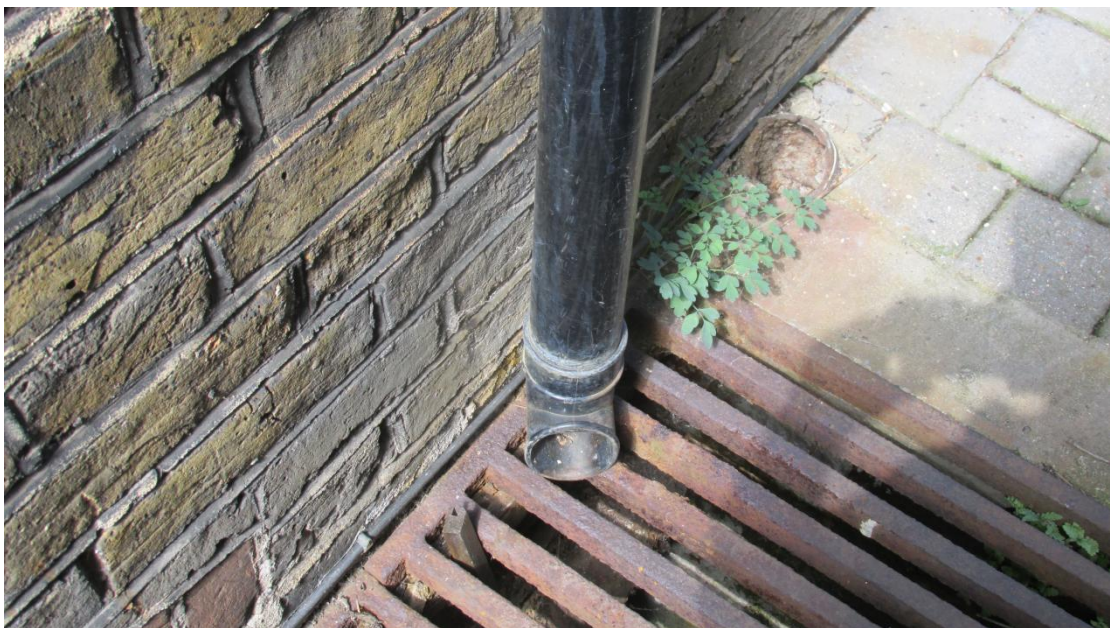
Rain water draining into the basement of the property

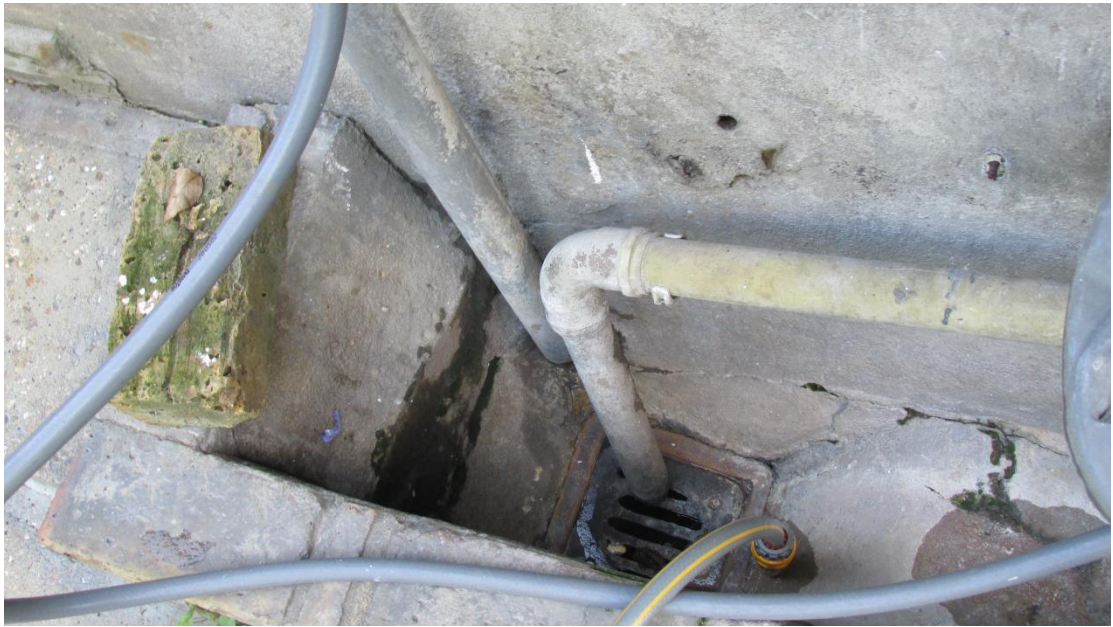
Rainwater gully at the rear

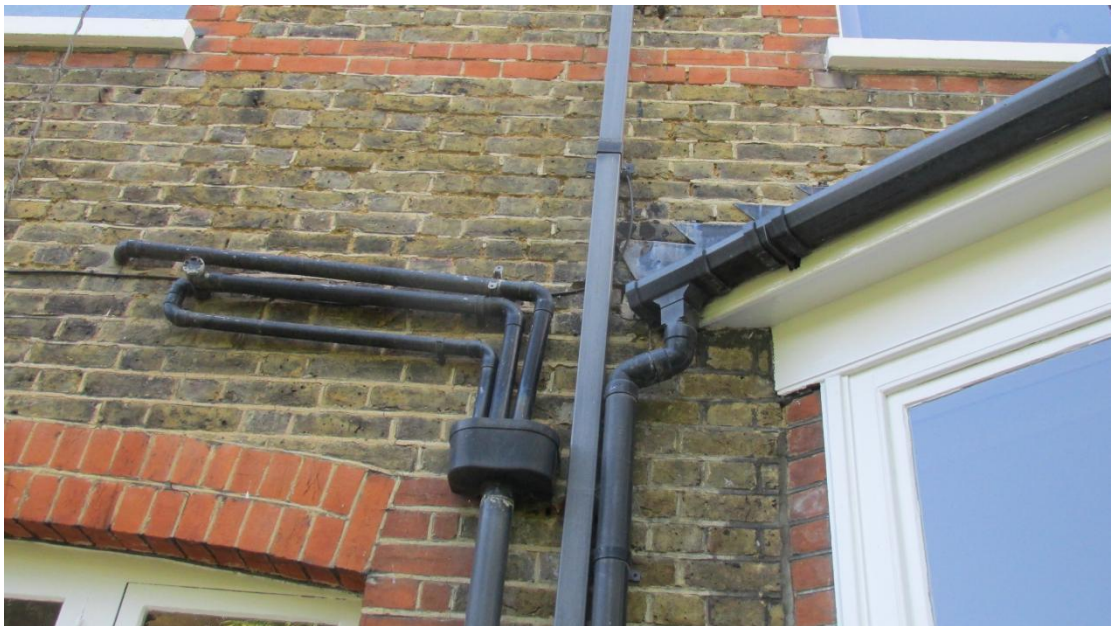
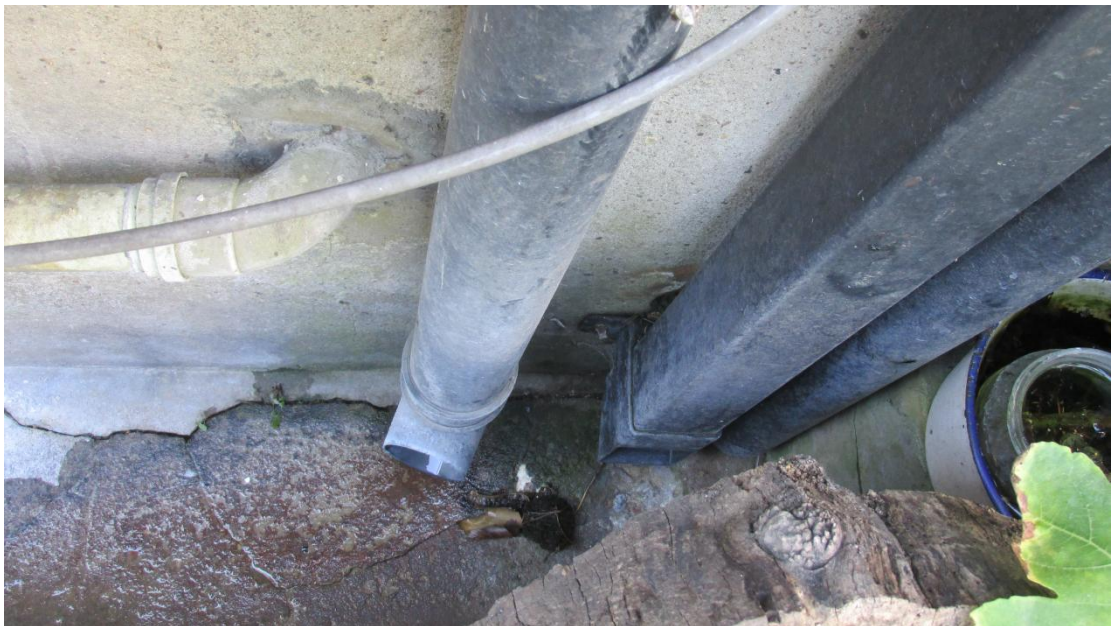
Rainwater pipe and gully at the rear

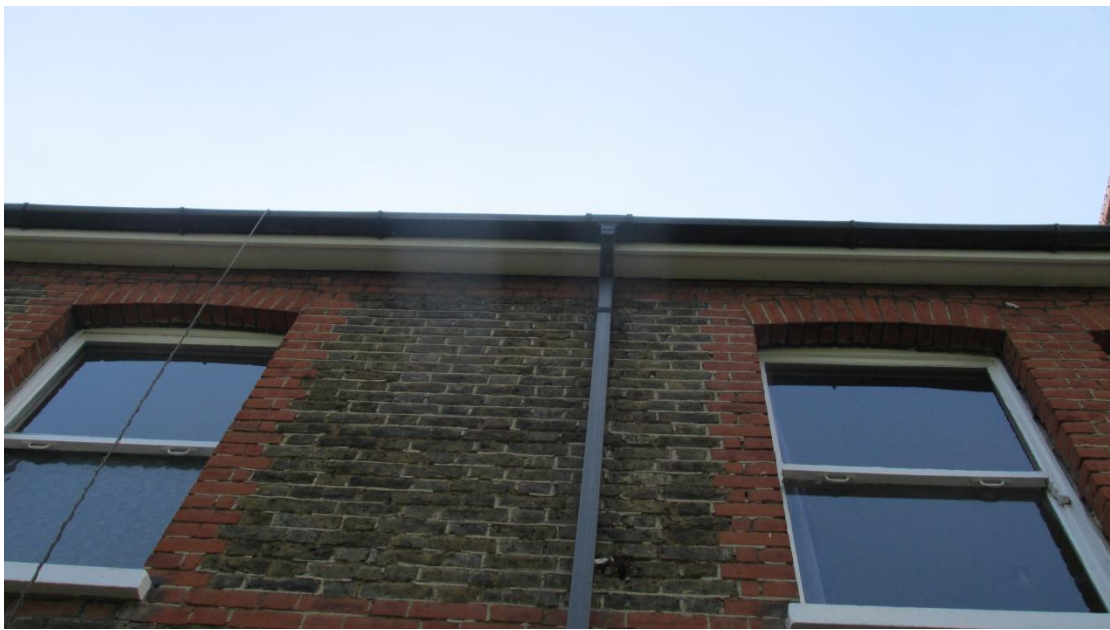
Gutters at the rear

The rainwater fittings at the front and rear are probably serviceable in the short term but are old. Gutters may leak where seals fail. Cleaning of fittings or complete replacement are both options. Improvements and alterations may be needed at any rate. The overall condition of the gutters and downpipes is average.

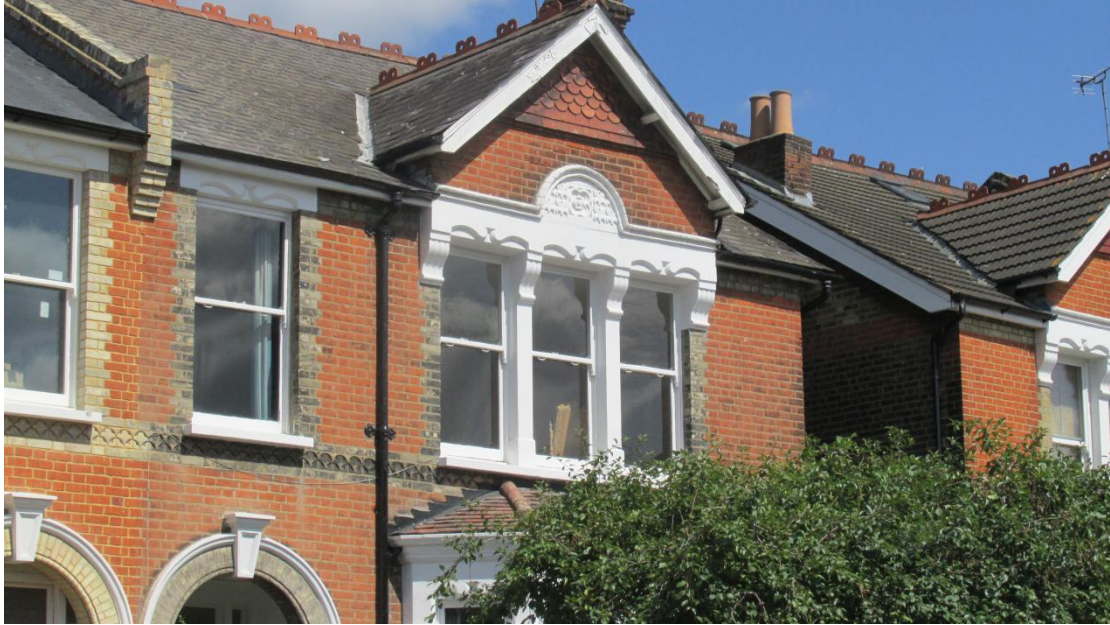
Front walls partially covered with clay tiles cladding

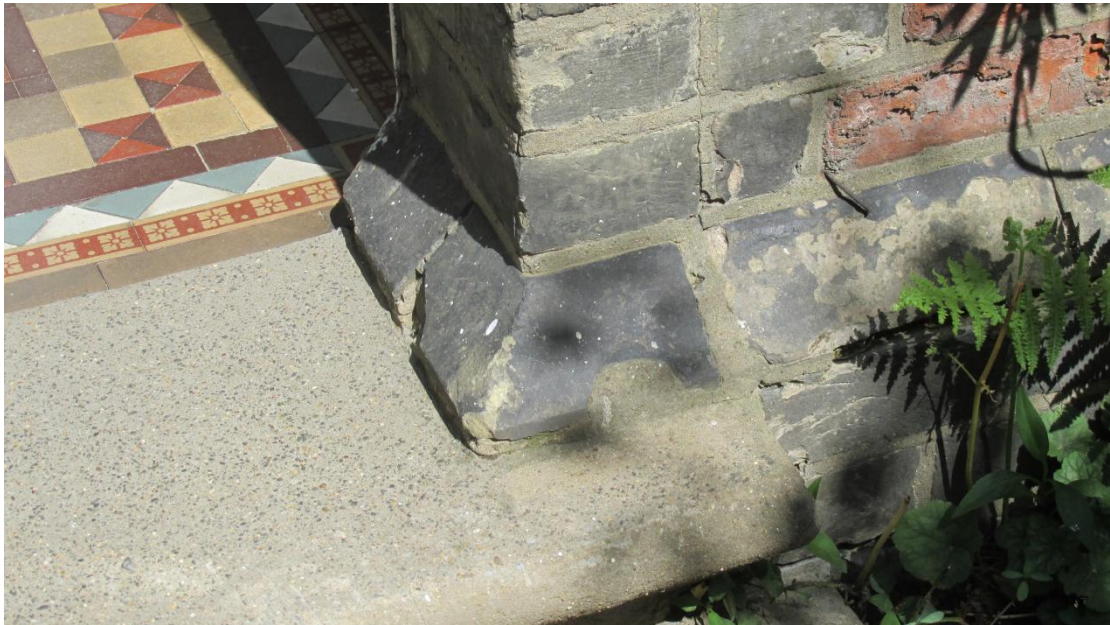
Wall near the entrance door

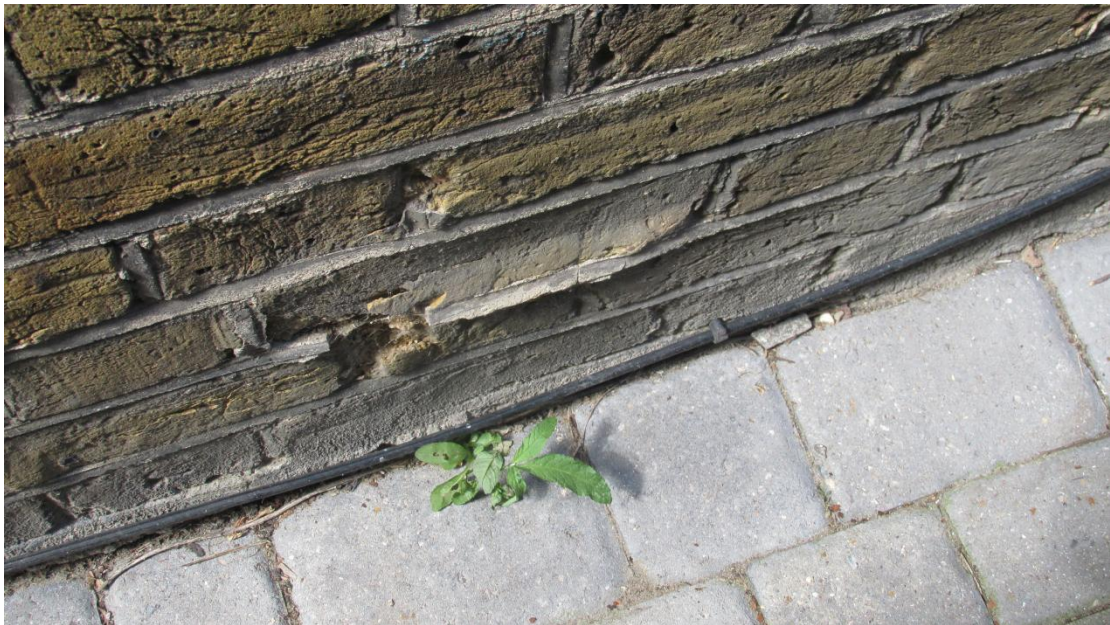
Side wall

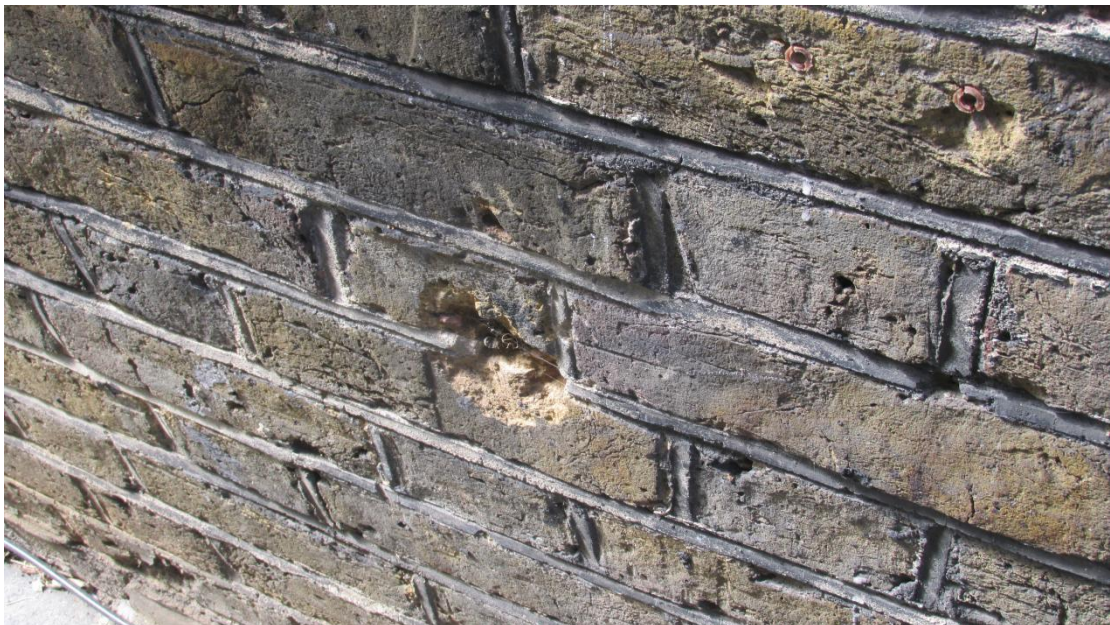
Damaged bricks on the side wall

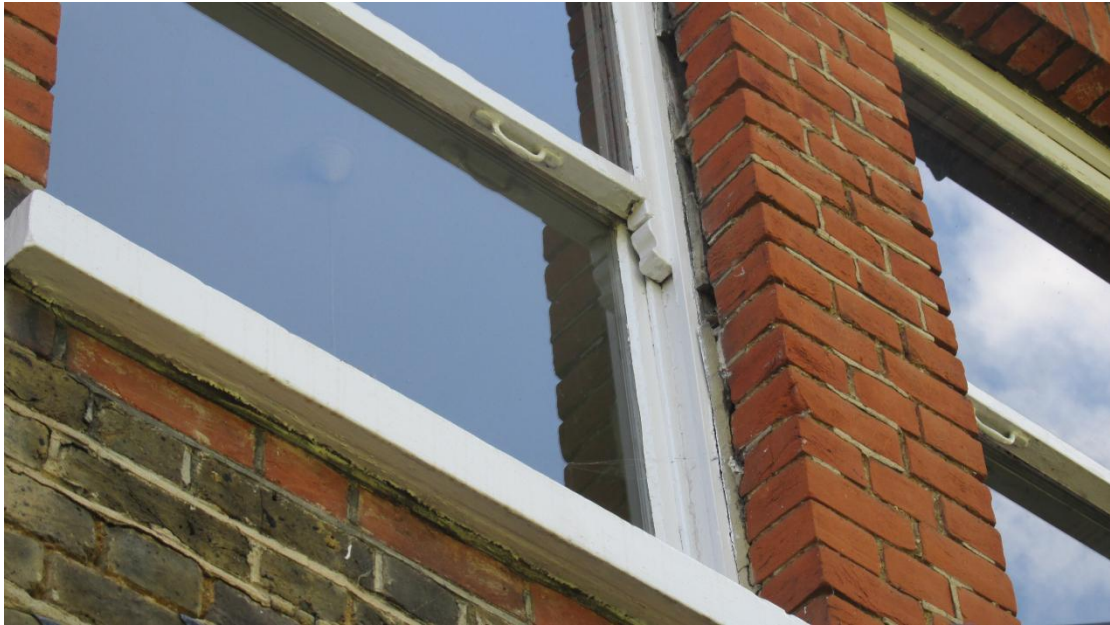
Missing pointing from the rear wall

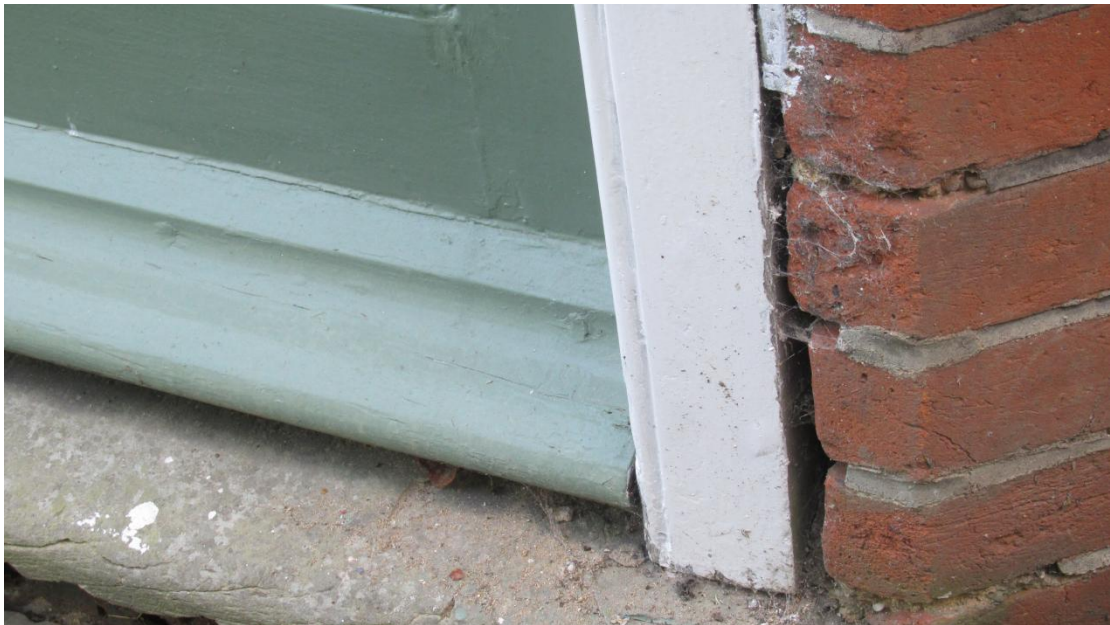
Rear wall near the door

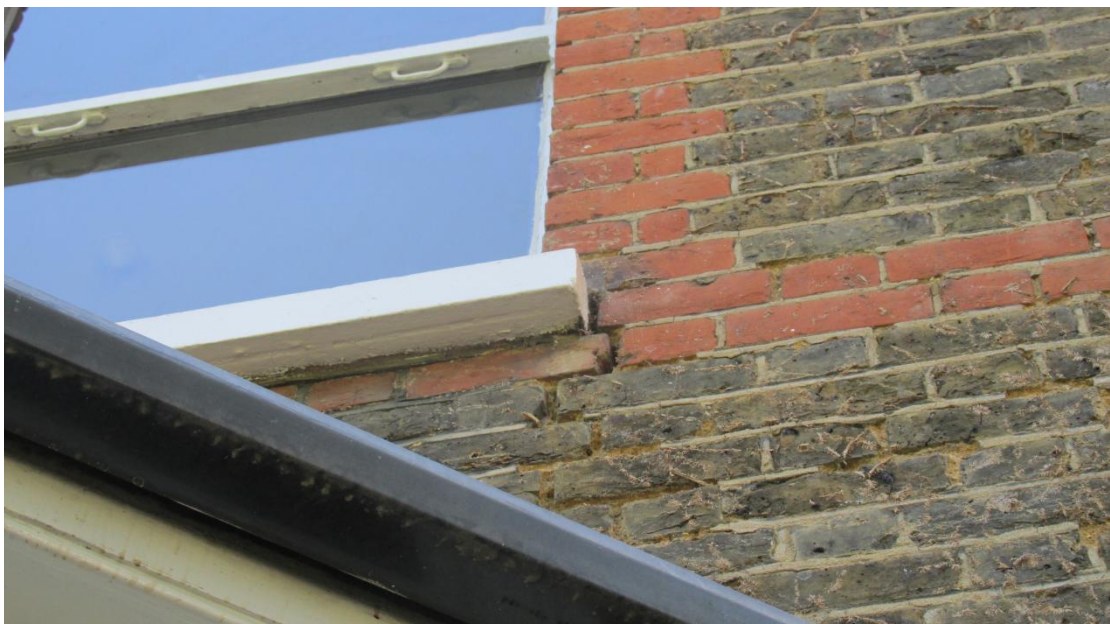
Rear wall above the bay window

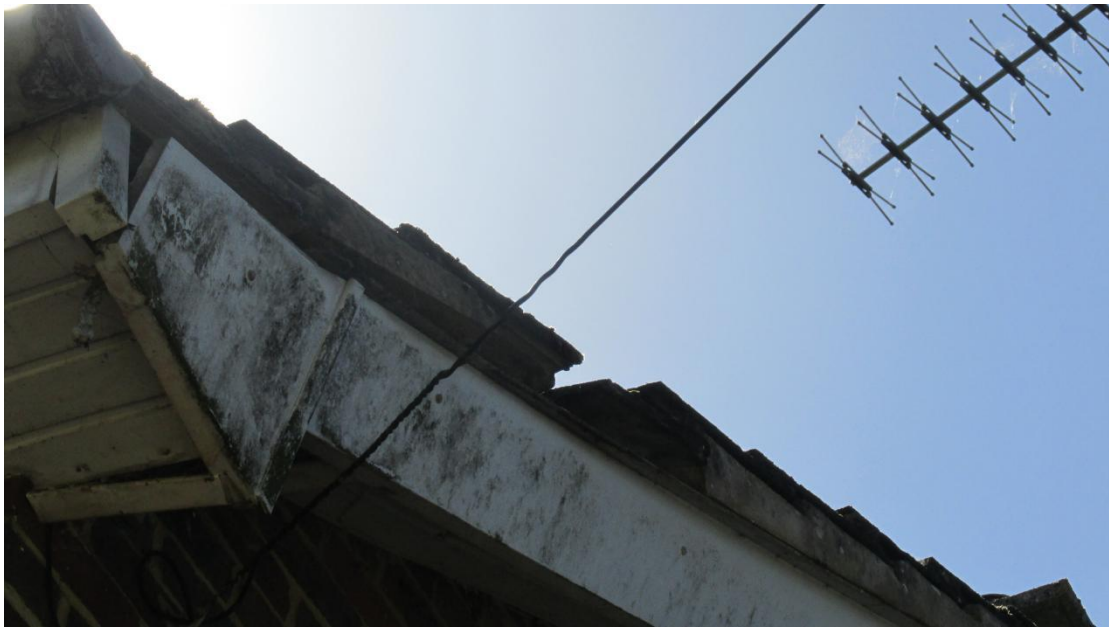
Broken soffits and barge board at the front right

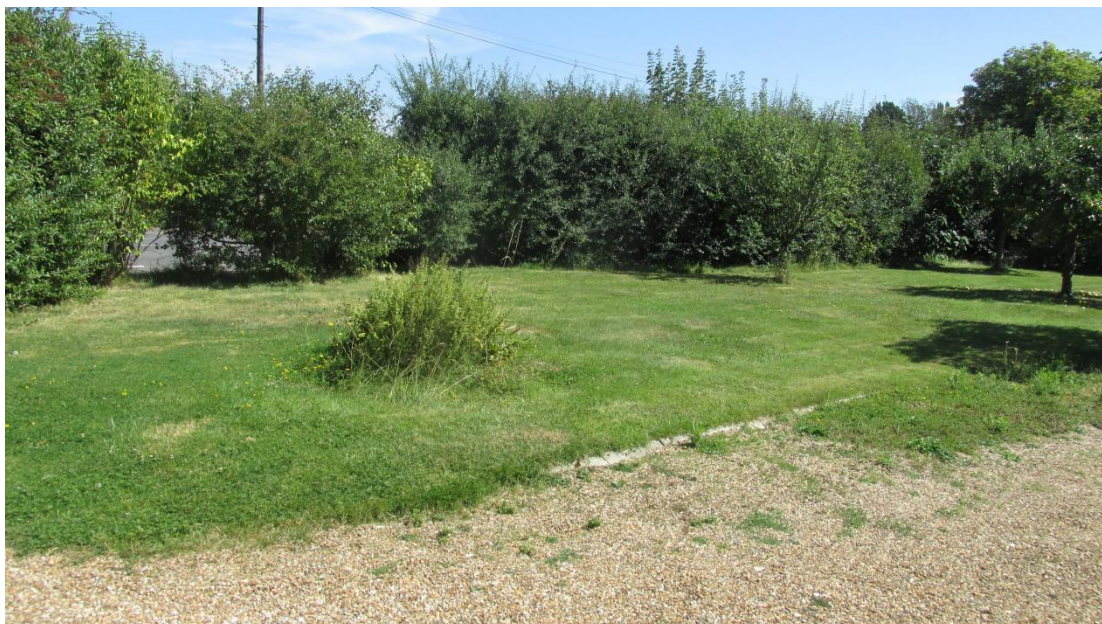
Overgrown front hedges

The boundary hedge in the front garden is overgrown. You may have to consider the cost of repairing the front entrance gate in future, but this is not urgent.

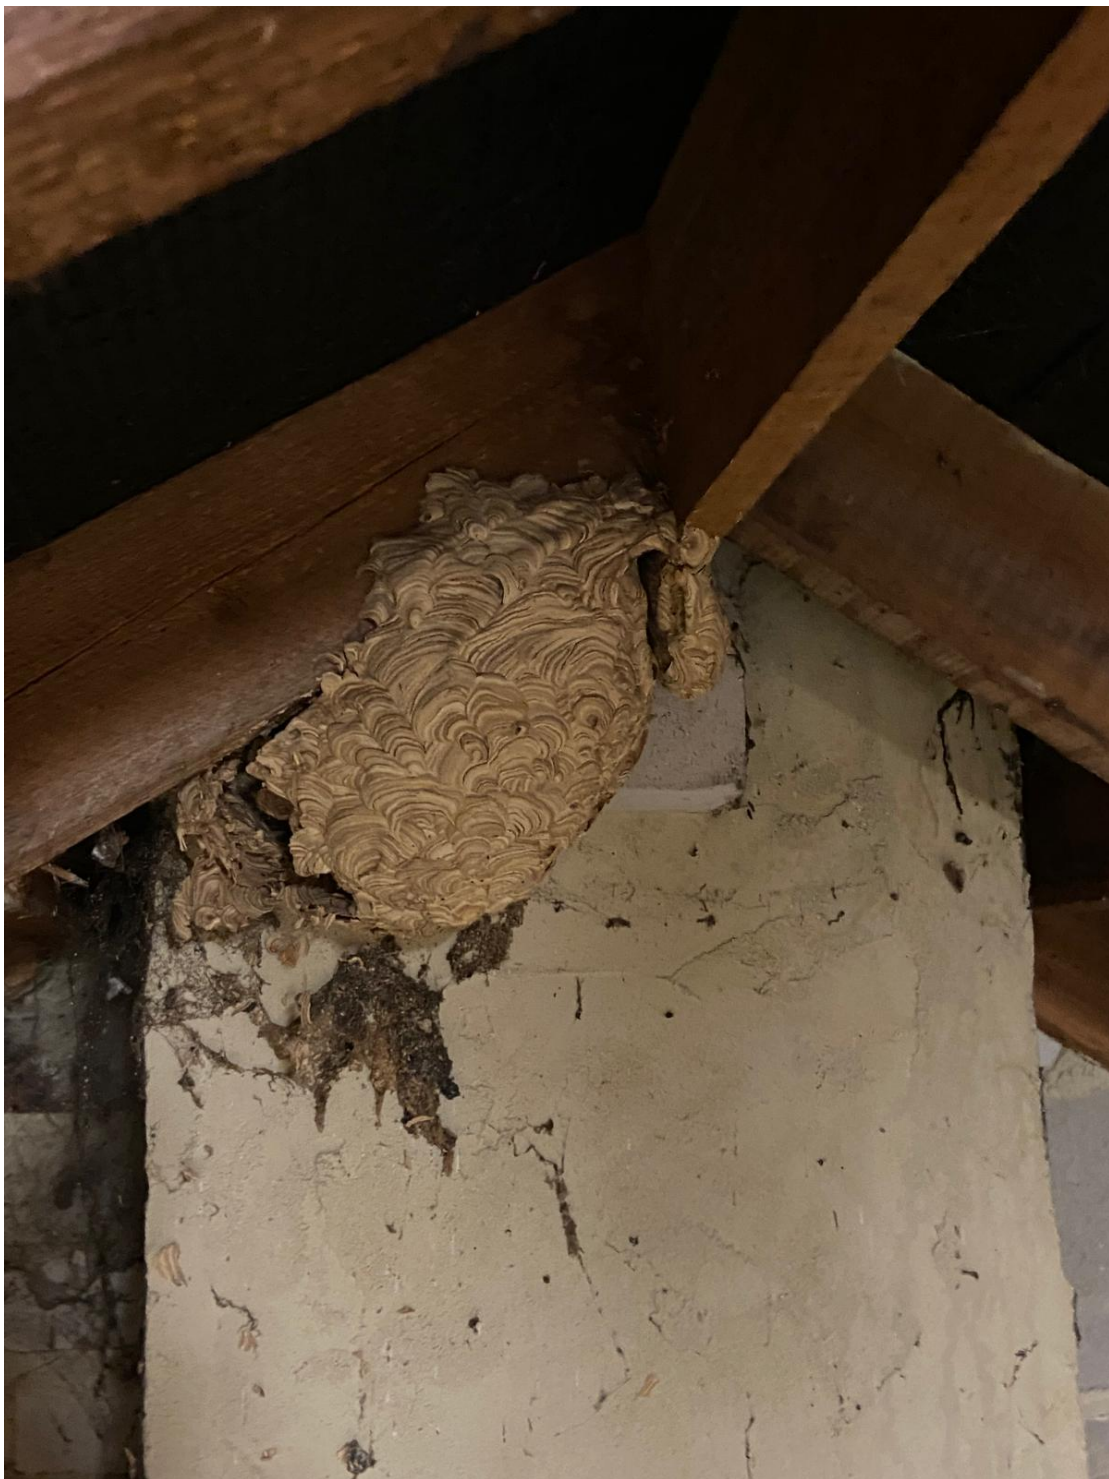
Wasp nest in the roof space
