LEVEL 3

# Your survey report...

Inspection date  
16/08/2024

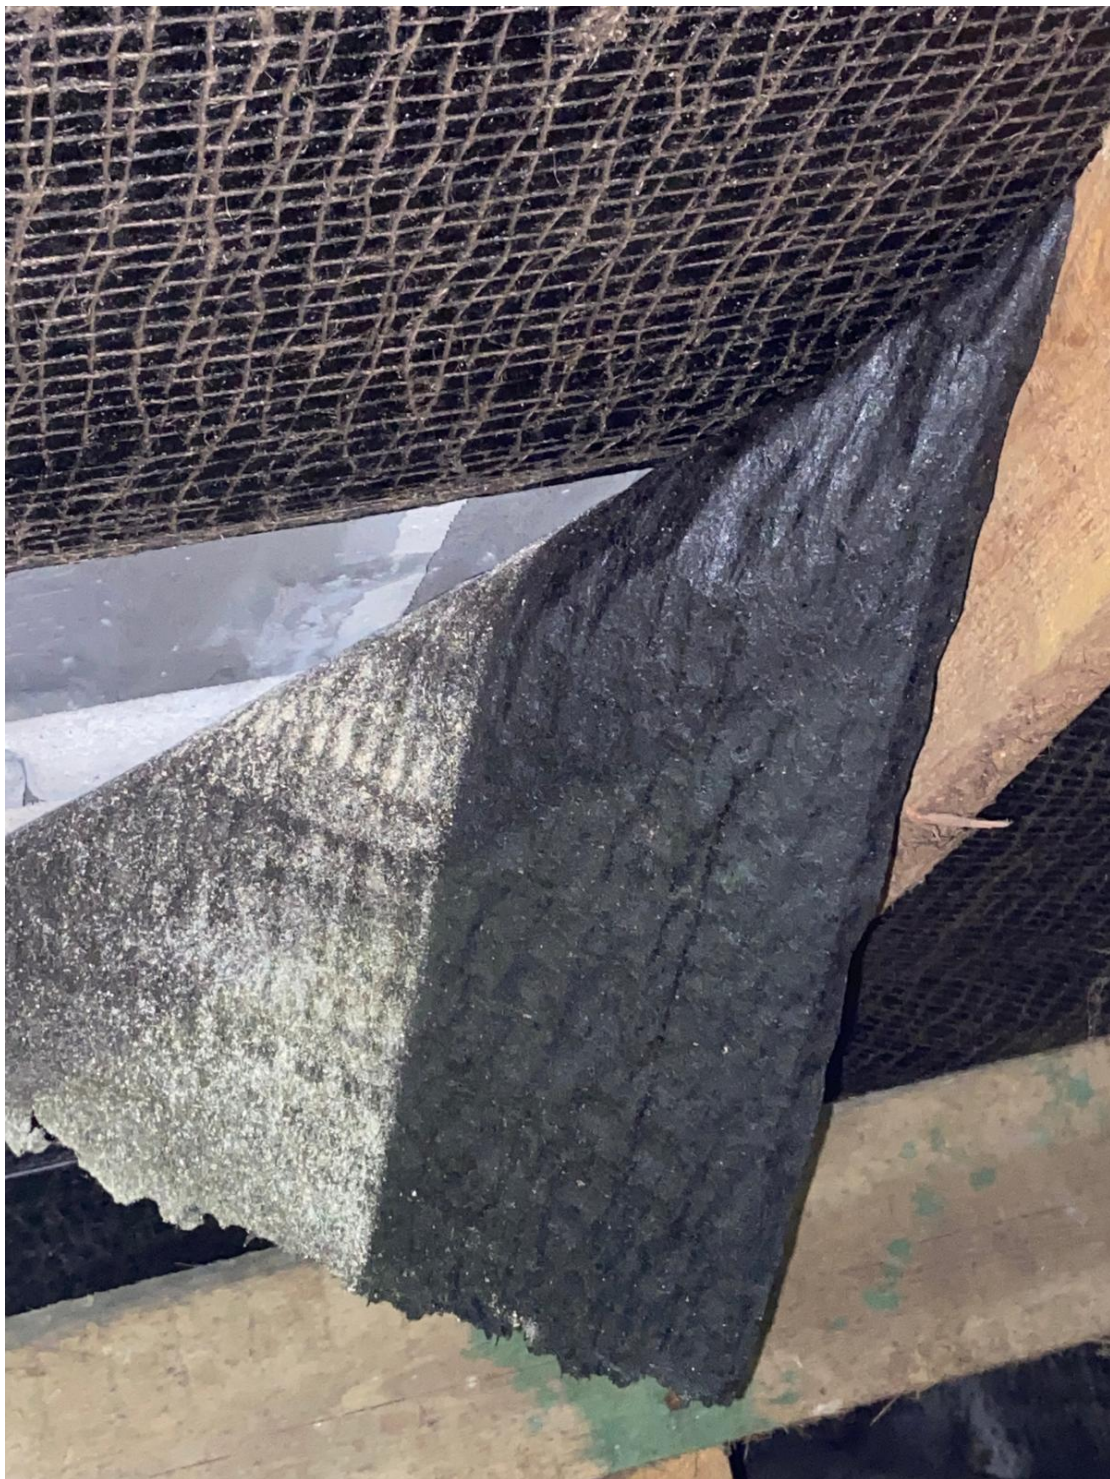
Broken felt under tiles

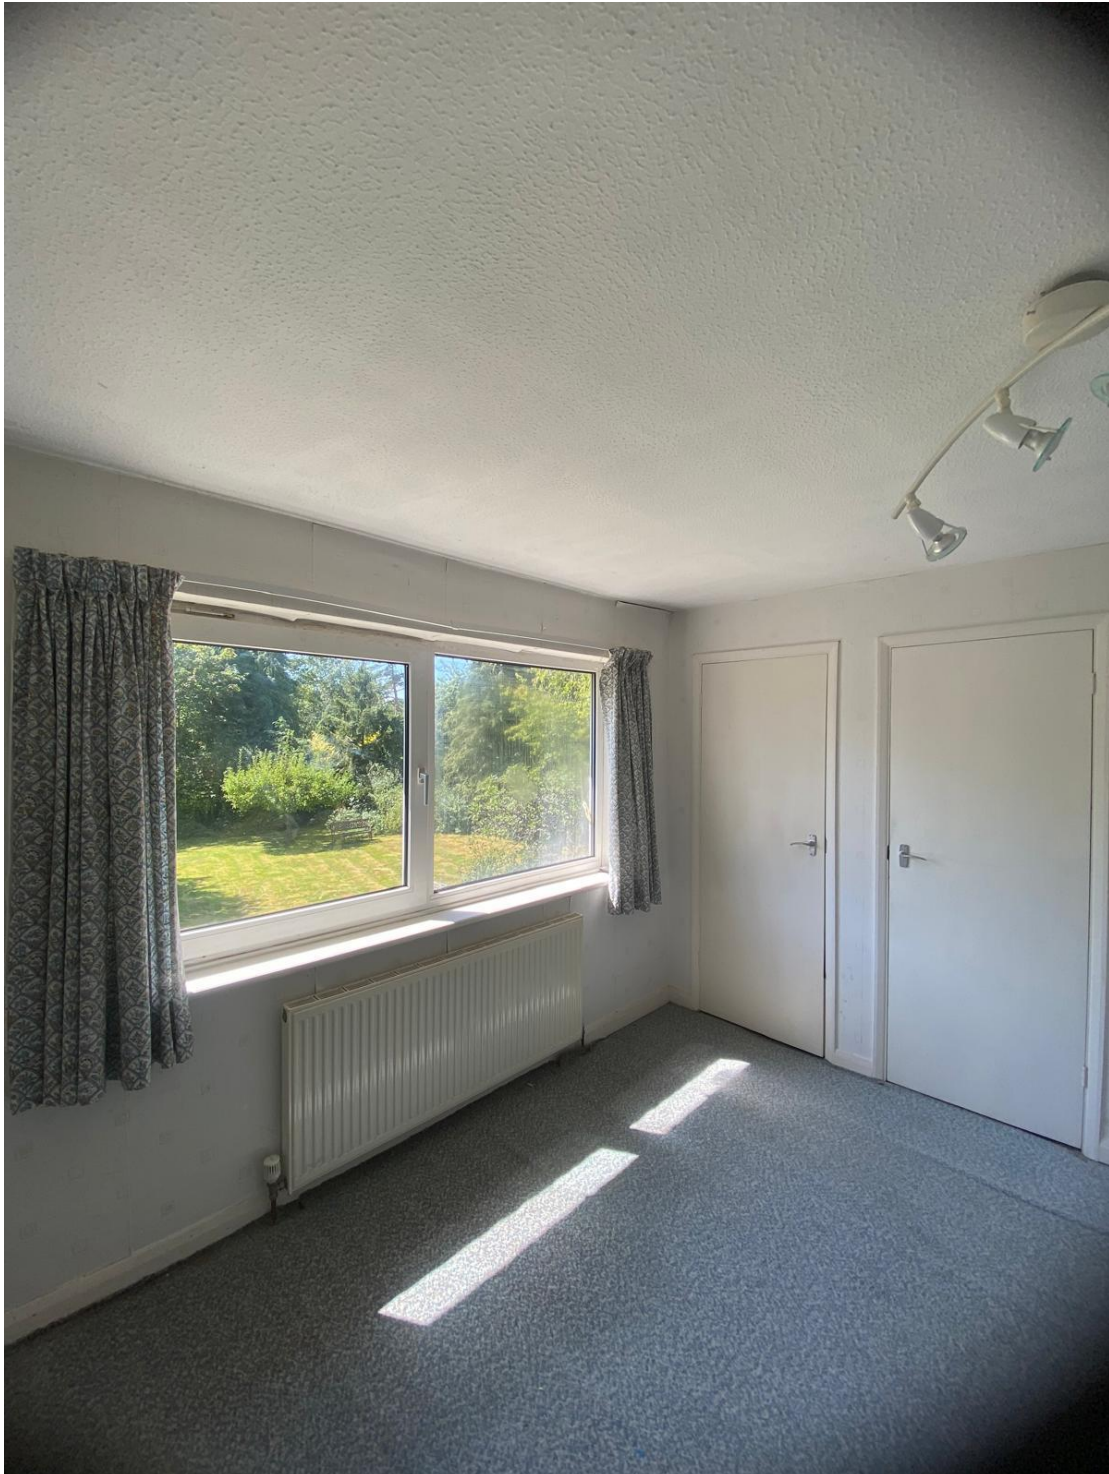
The ceilings are made of plasterboard and have smooth and textured area finishes. They are generally secure and even. However, the ceilings in the bedrooms above the windows have some signs of mould, which shows the lack of insulation in the property.

Ceiling in the rear bed room

Some minor damage from cracking and some staining can be dealt with through regular decorative maintenance. Get quotations from qualified persons to remedy these issues.

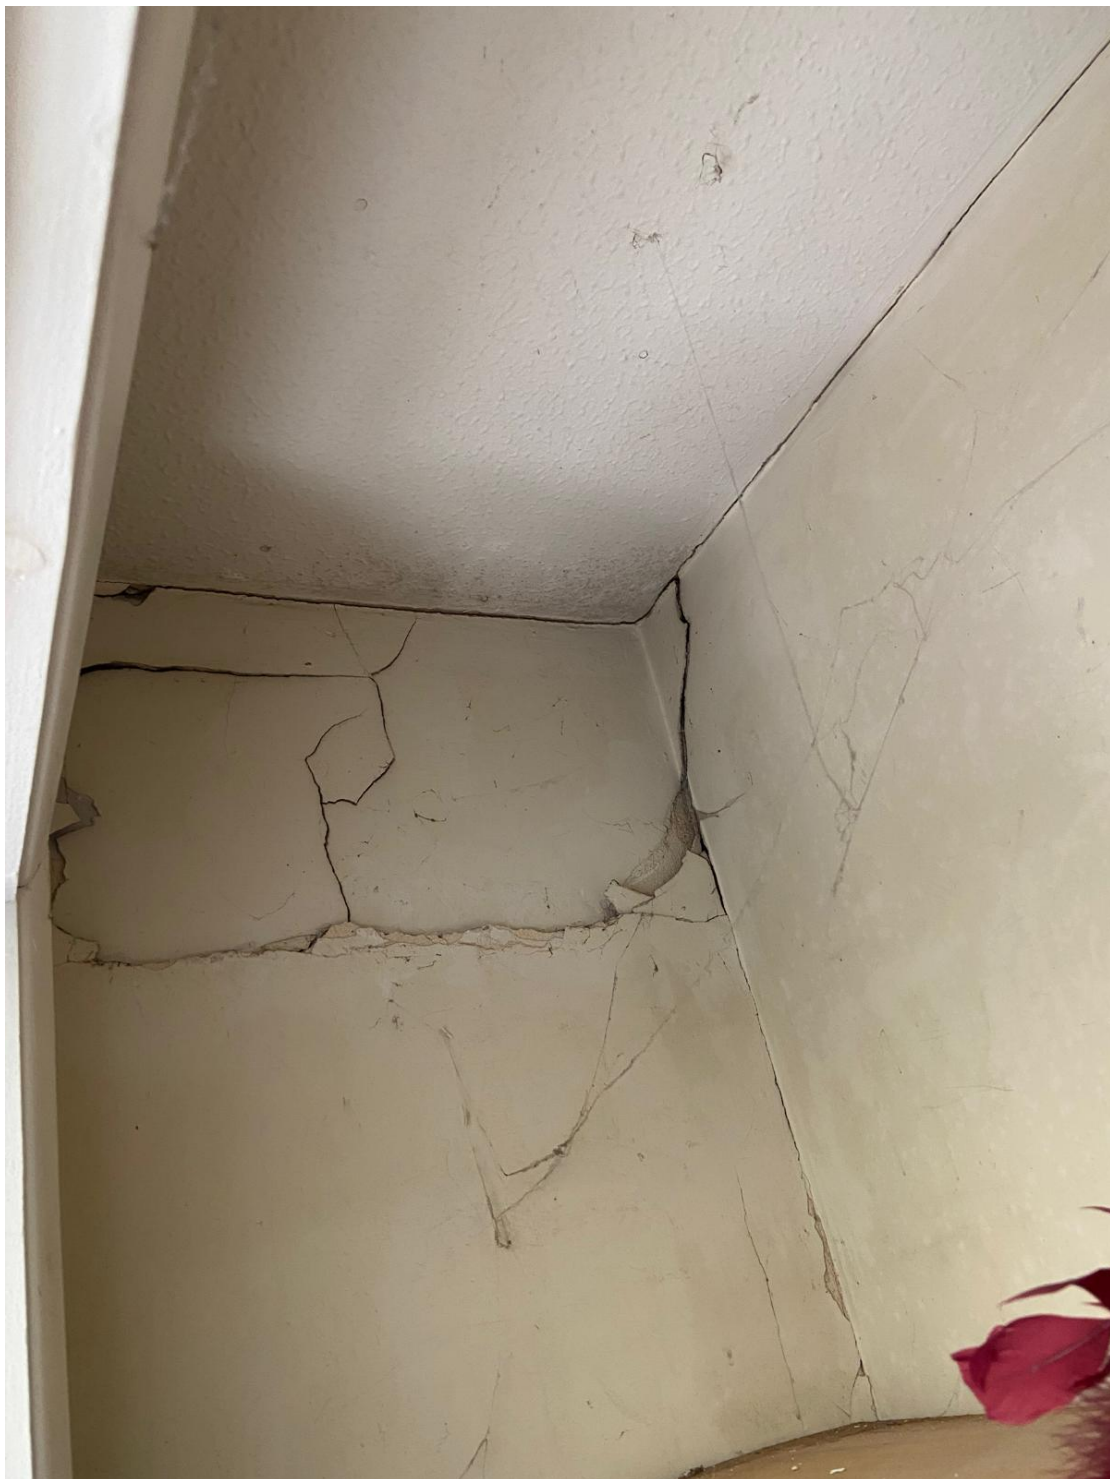
Outside wall of the rear bedroom in the cupboard

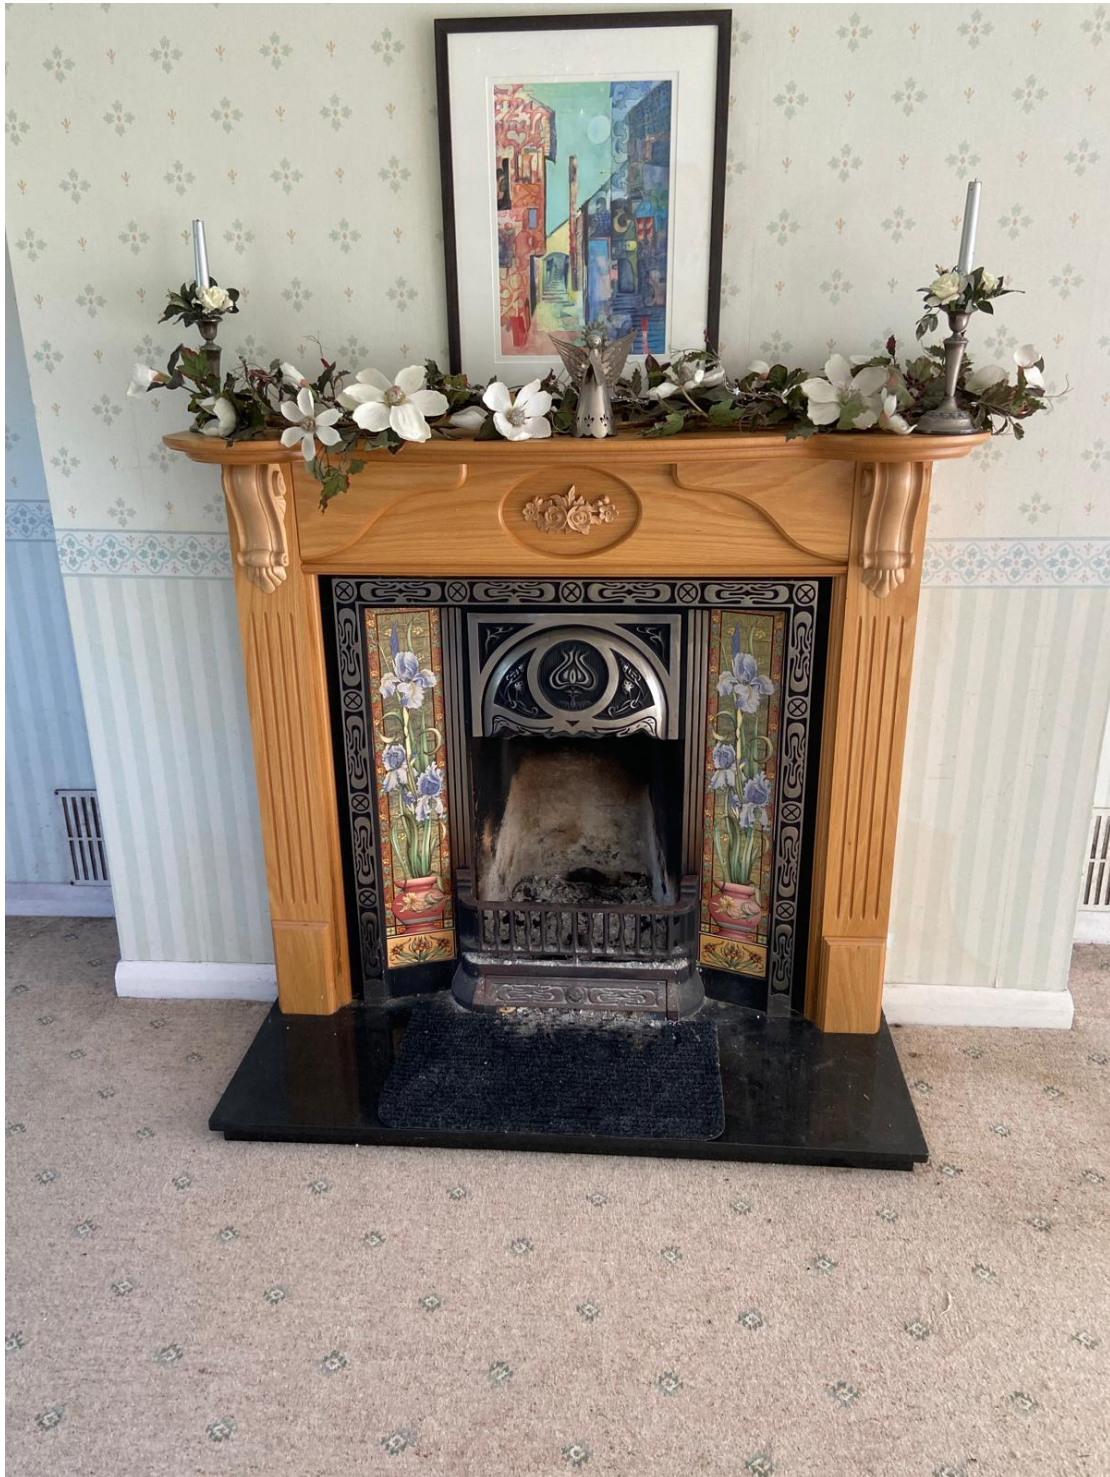
There is a wood burner in the living room. I assume that it is still in use. I recommend that my client ask for a recent safety certificate from a HETAS-qualified person. Until the safety certificate is provided, it will be rated 3.

Fireplace in the living room

A condition rating 3 has been applied because there are defects that are serious and/or need to be repaired, replaced or investigated urgently.

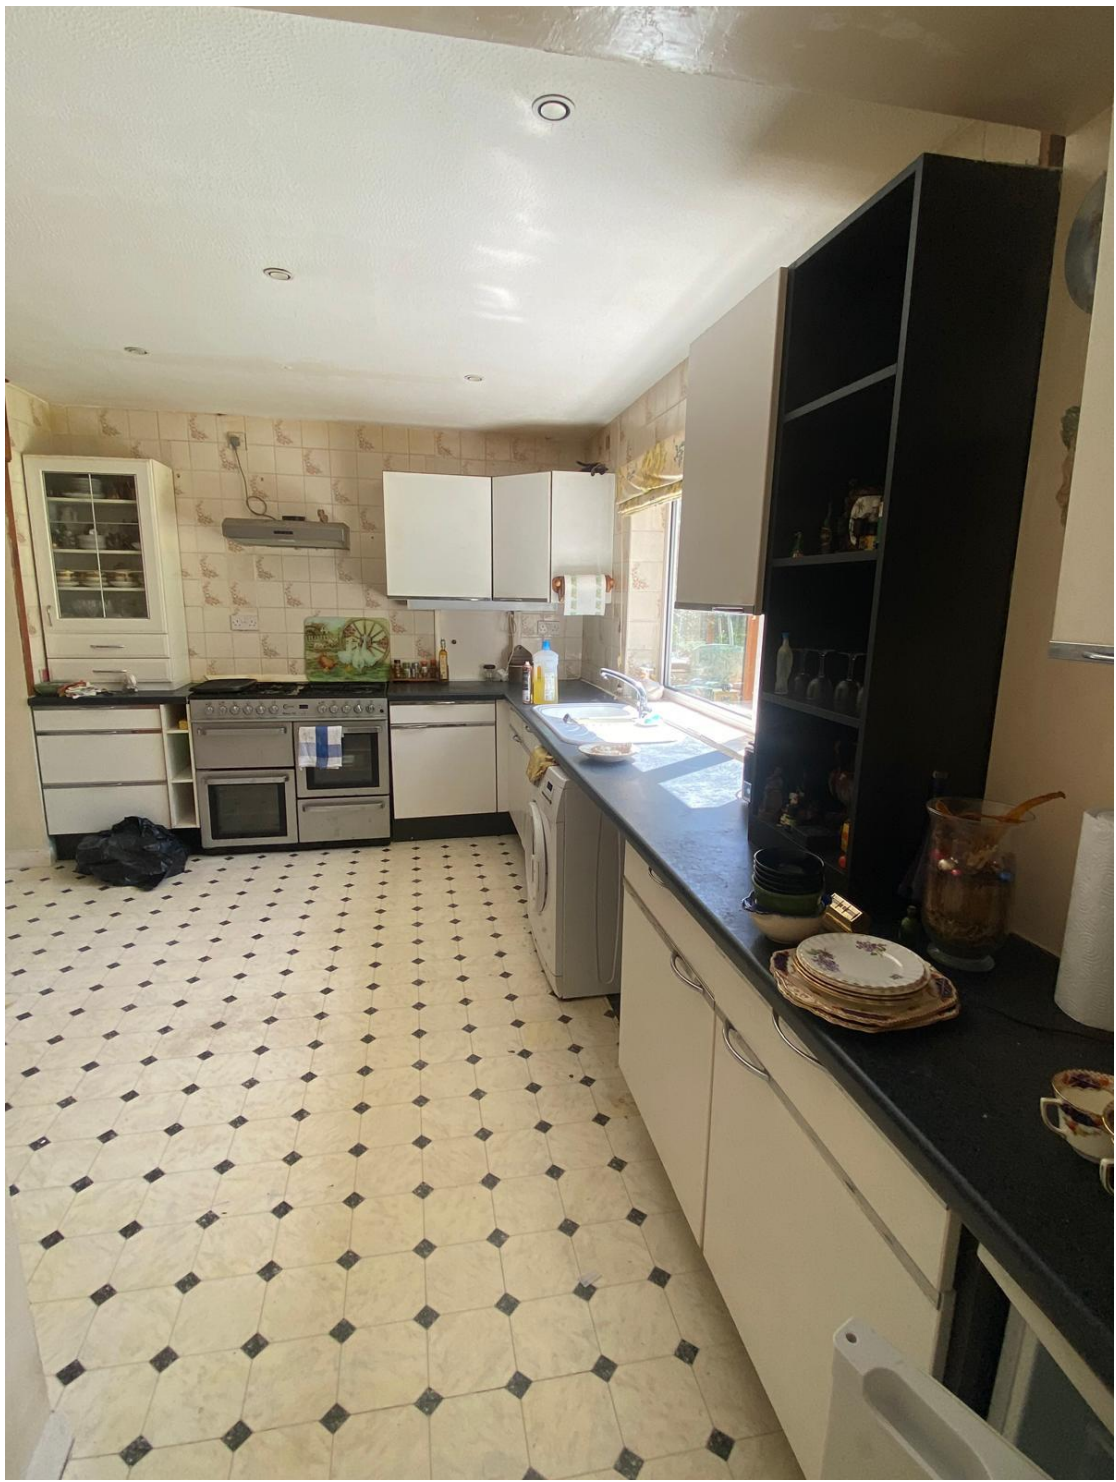
The kitchen and utility fittings are very basic and there is wear and tear. You should work on the basis that some replacement will be required. It would be prudent to revisit the property to ensure you are happy with the kitchen and utility areas.

Kitchen fittings

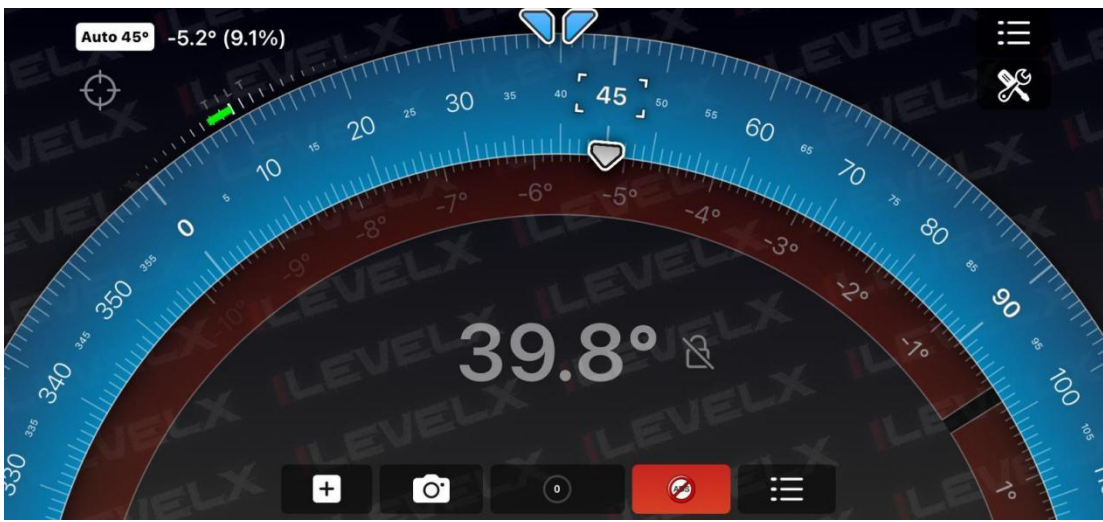
lower than current regulations at 800mm high (the recommended minimum is 900mm). The slope of the staircase is 39.8 degrees instead of 42 degrees, which is the recent standard requirement.

Slope of the staircase

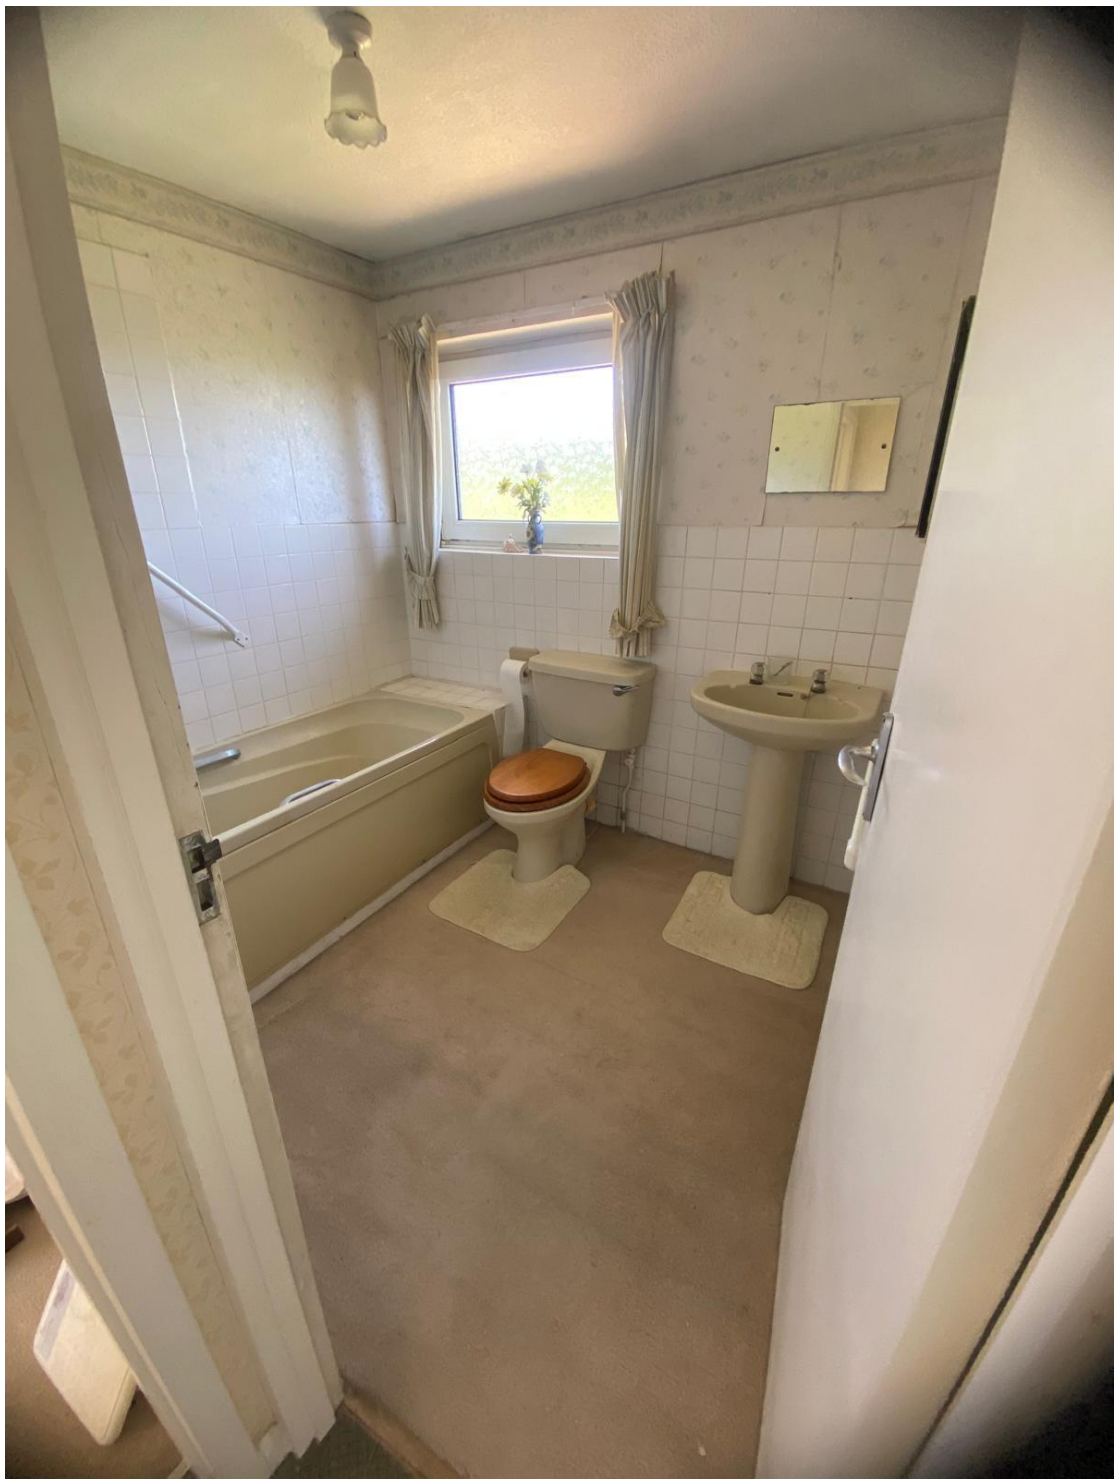
There is an extractor fan but not in working condition, so steam remains in the bathroom, leading to condensation-related mould. The fittings are serviceable but very basic and worn. Bathrooms are subject to personal taste. You should revisit to confirm that they are to your taste.

Family bathroom

Mould treatment is required in the bathroom before redecoration as part of normal maintenance. A powered extractor to vent the room is highly recommended to ensure a healthy living environment.

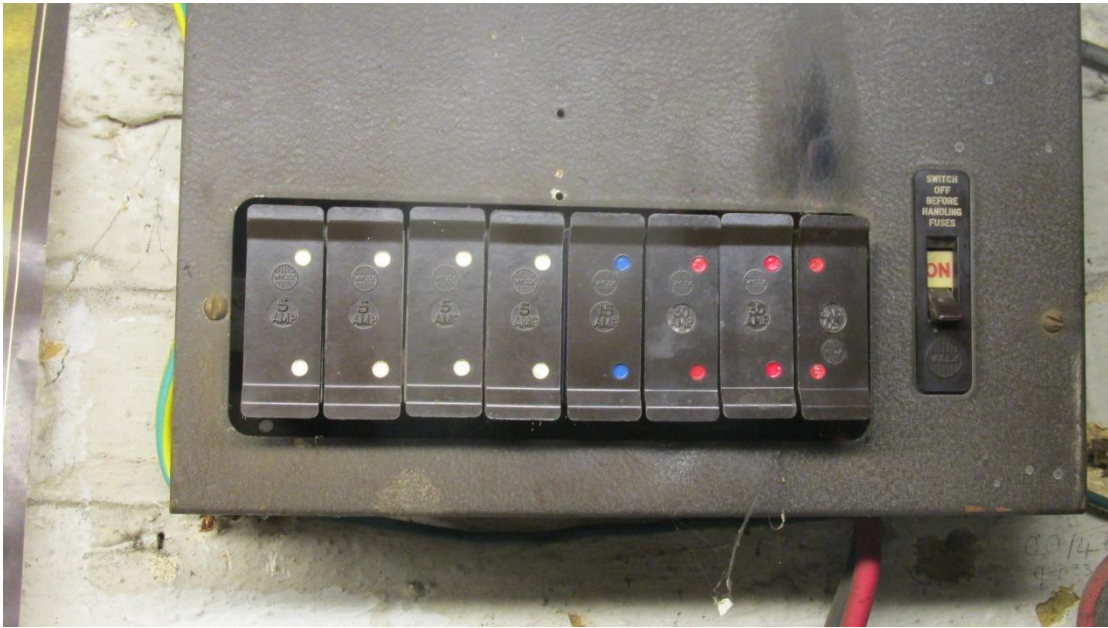
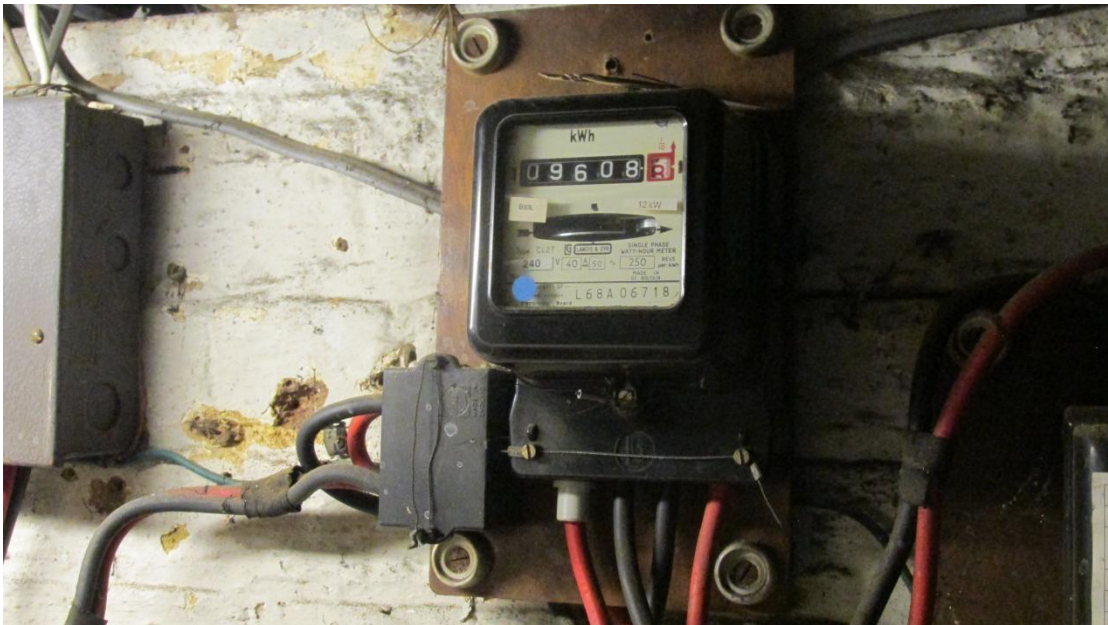
Consumer unit and Electric meter in the basement

It is simply impossible without testing to know how safe the system is and an Electrical Installation Condition Report (EICR) from a registered electrician is advised prior to exchange of contracts, unless the vendor is able to supply such certification. Condition rating 3 applies.

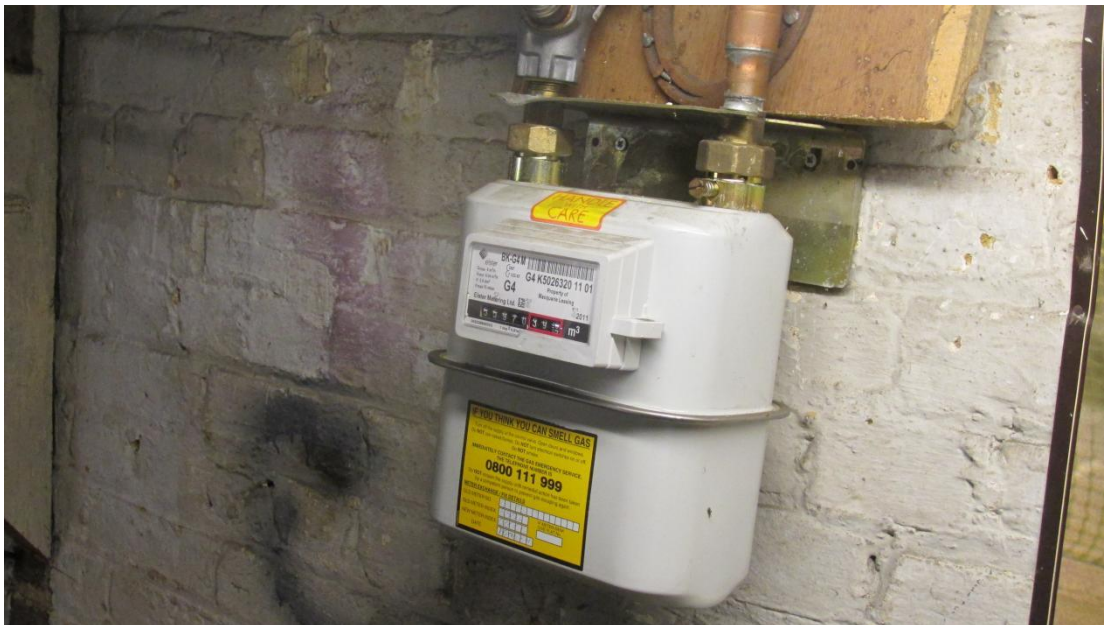
No evidence of the gas installation having been recently safety tested was seen and **for this reason a condition rating 3 applies.**

Gas meter in garage

A Gas Safe registered engineer must inspect the installation before exchange of contracts unless the owner is able to supply such certification. All parts of the system must be inspected. This issue has been raised in section I for your legal adviser to pursue.
