LEVEL 3

# Your survey report...

Inspection date  
16/08/2024

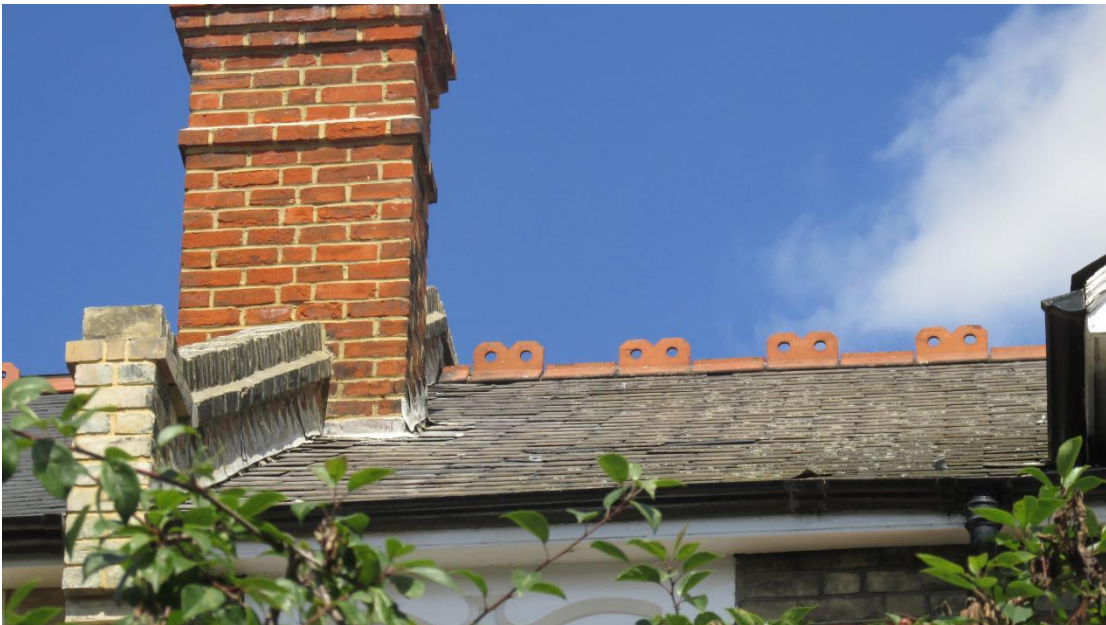
Left chimney stack flashing

The condition of the chimney appears to be satisfactory because most of the pointing is intact. Some of the bricks on the right chimney stack show signs of frosting. They might need replacing soon. The lead dressing at the base of the stack is to prevent water ingress. It is in below-average condition. It does seem to be watertight.

The cement bedding around the chimney pots' base (flaunching) could be weathered and deteriorated. I have observed lichen growing on flaunching.

The missing pointing on the chimney stack must be repaired. The condition of the flaunching should also be investigated and repaired. Ensure the lead flashing in the base performs well and is watertight.

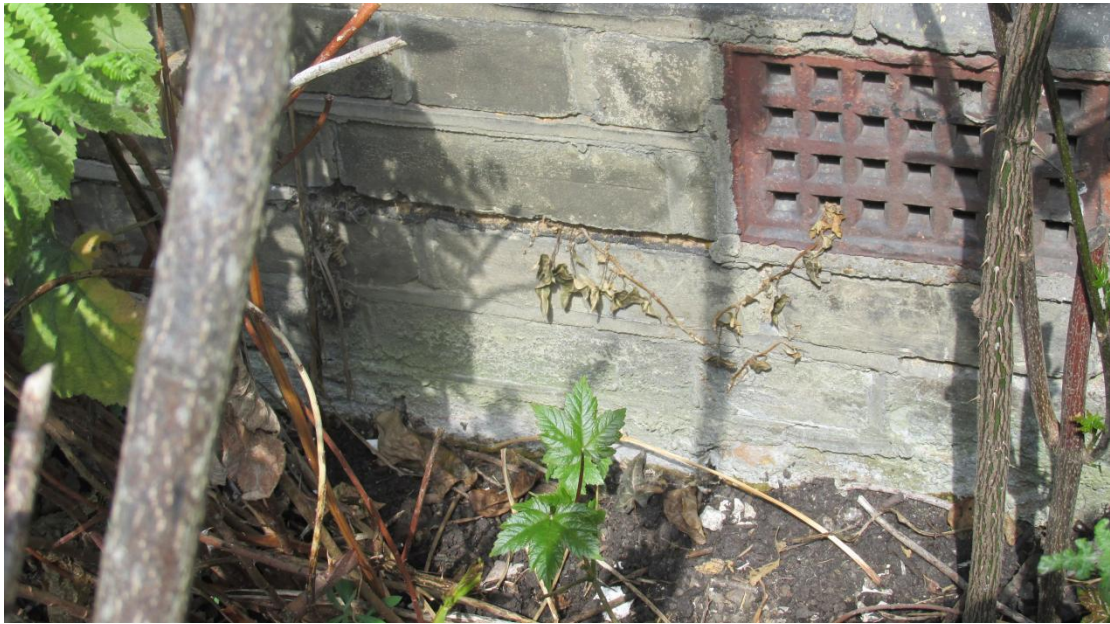
Wall under the bay window

3- There are some 1mm to 2mm cracks on the front outside wall of the house under the bay window. This issue should be monitored, investigated, and resolved.

My firm would be happy to conduct a more detailed inspection, provide you with a report, and recommend a repair scheme. This would be under a new agreement between us. Parts of the property will have to be disturbed to do this properly. Evidence of former building movement can affect future property mortgage suitability and saleability.

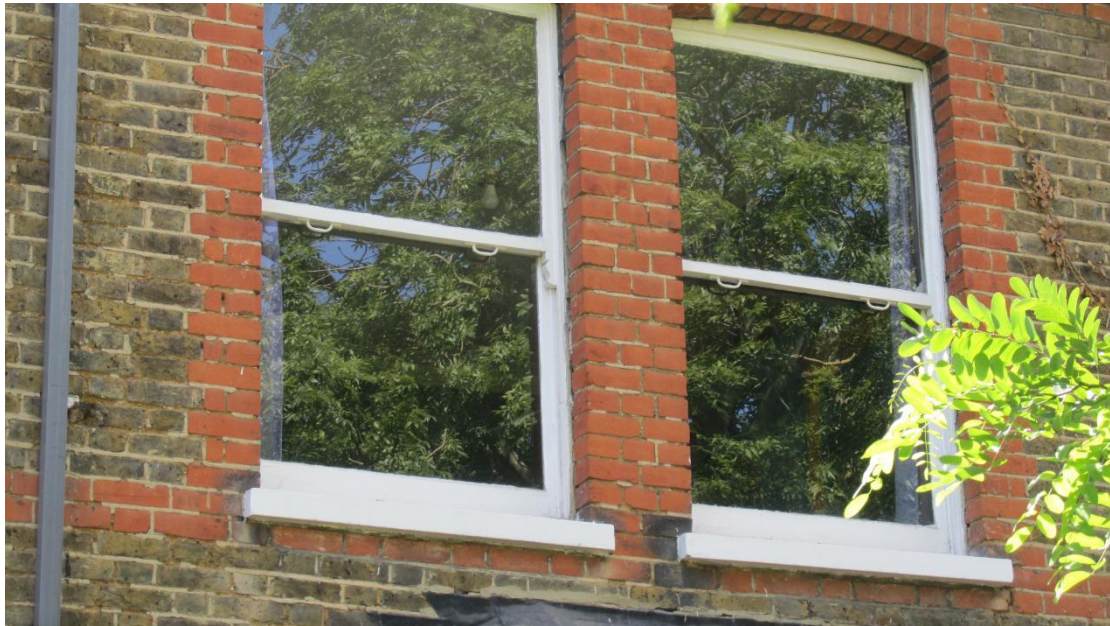
Rear sash timber window

The glazing to the low-level window is unlikely to be safety glass and would be a safety hazard for anyone who falls against it. You should ask an appropriately qualified person for advice. The windows in the subject property are in below-average condition. Windows could be more energy-efficient and in better condition. The windows are timber frame single-glazed top-hinged casement types without trickle vents. The bedroom window does provide an adequate secondary fire escape in the unlikely event of needing it, except for the staircase. Opening restrictors should be provided for the upper-floor windows. Confirm whether this is the case. The windows have loose and stiff hinges. They have to be repaired or replaced. I would recommend to get quotations to avoid future surprises. The issue of legal compliance for doors and windows has to be raised for your legal adviser to pursue. No trickle vent is installed in the windows, which can cause condensation and mould in the long run.

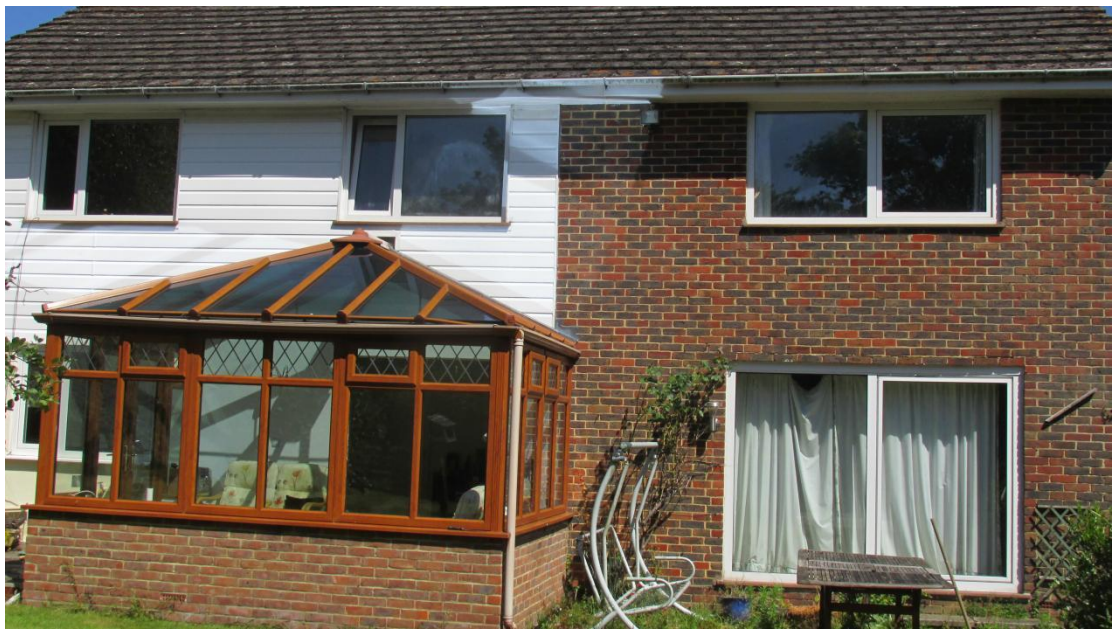
Rear patio door

The front door is a multiple-panel timber door. The rear door to the garden is a double-glazed PVCU door from the kitchen and living room into the garden patio. This door is a bit stiff. It should be repaired for smooth closing. The front and rear doors are believed to be in satisfactory condition. The PVCU door from the living room into the garden was closed and had restricted access; therefore, I could not open it. I can not confirm if this is working. While there is single locking at the front and rear doors, it's important to note that the current situation with the locks is not ideal. The fact that it's not known who might hold the keys and the loose handle are potential security risks that should be addressed. We strongly recommend considering a lock change to ensure the safety of the property. The legal compliance issue for doors and windows should be raised for your legal adviser to pursue.

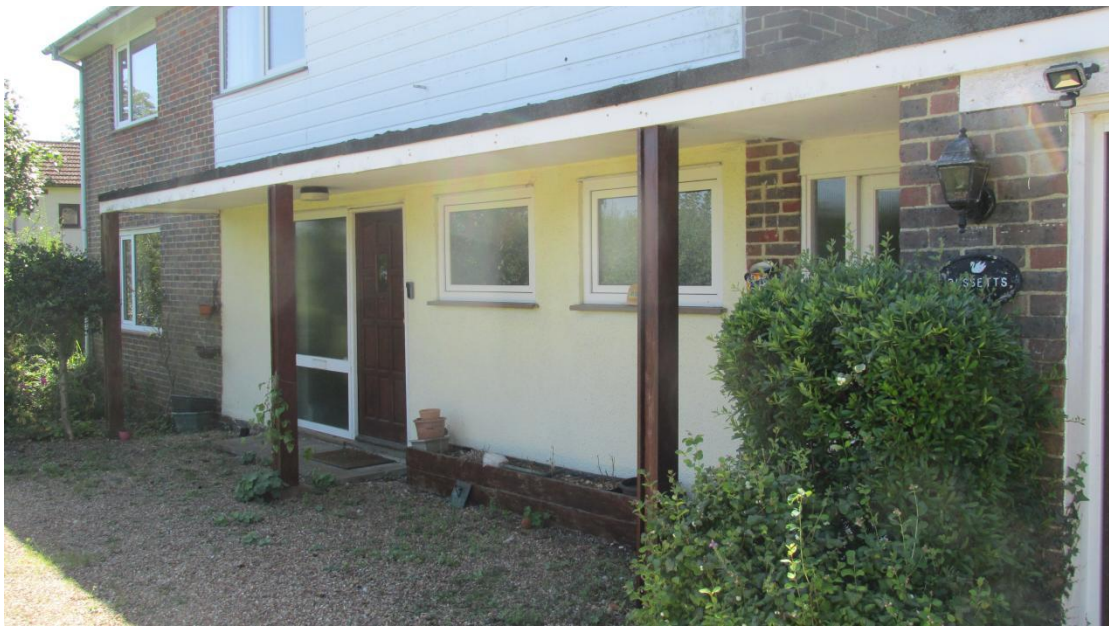
Front porch/veranda

The front porch is in average condition. The front porch has not been decorated recently; keeping a good look at this part is necessary. Outside decorations help keep the property in satisfactory condition. Without a protective finish, parts will quickly deteriorate, requiring extensive repairs. To prevent this, the external surfaces should be redecorated soon. The work is not urgent.

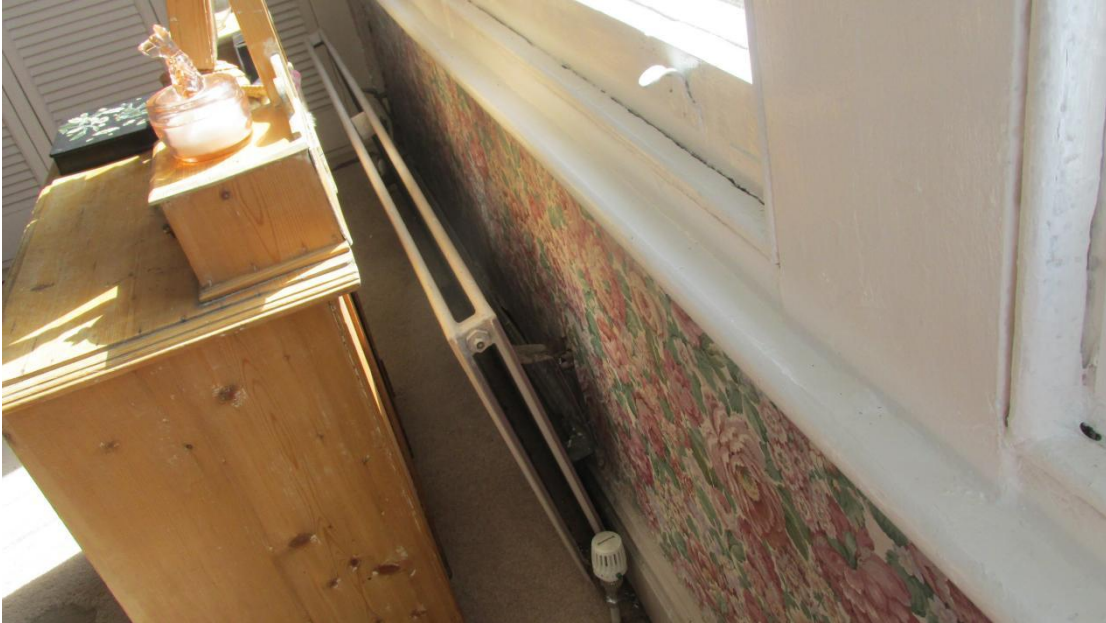
Radiator in the front bedroom

There is central heating in the property. It seems to be very old. I do not know if it is in working order. The issue of servicing and safety certification should be raised for your legal adviser to pursue.

**A condition rating 2 has been applied because there are defects that are not serious and/or need to be repaired, get certification urgently.**

The surveyor is not a GAS engineer and beyond a cursory inspection cannot provide a technical assessment. For certainty on condition and performance of this system, further inspection by a competent GAS engineer would be required. This is highly advisable before exchange of contracts.

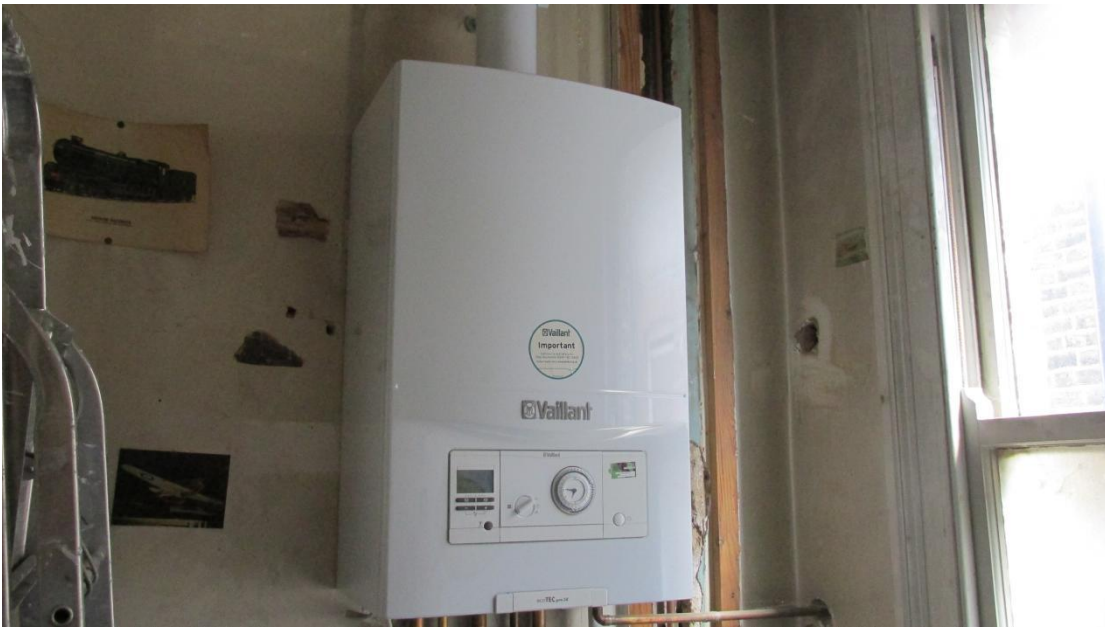
Boiler in the 1<sup>st</sup> floor cupboard

Hot water is heated by gas fired boiler. It would be reasonable to work on the assumption that some modernisation will be required. There is instant supply of hot water through the combi boiler.

**A condition rating 2 has been applied because there are defects that are not urgent and/or need to be repaired, replaced or investigated.**
